Subject: Allegation of Non-compliance regarding enforcing the Buffer Zone/Riparian Management Plan approved by the Commission in 2007. Project 516

**Report on Examination of Disturbed Areas
Lake Murray, SC**

Proposed by James D. Walters, Jr.

Prepared for Lake Murray Watch
October, 2025

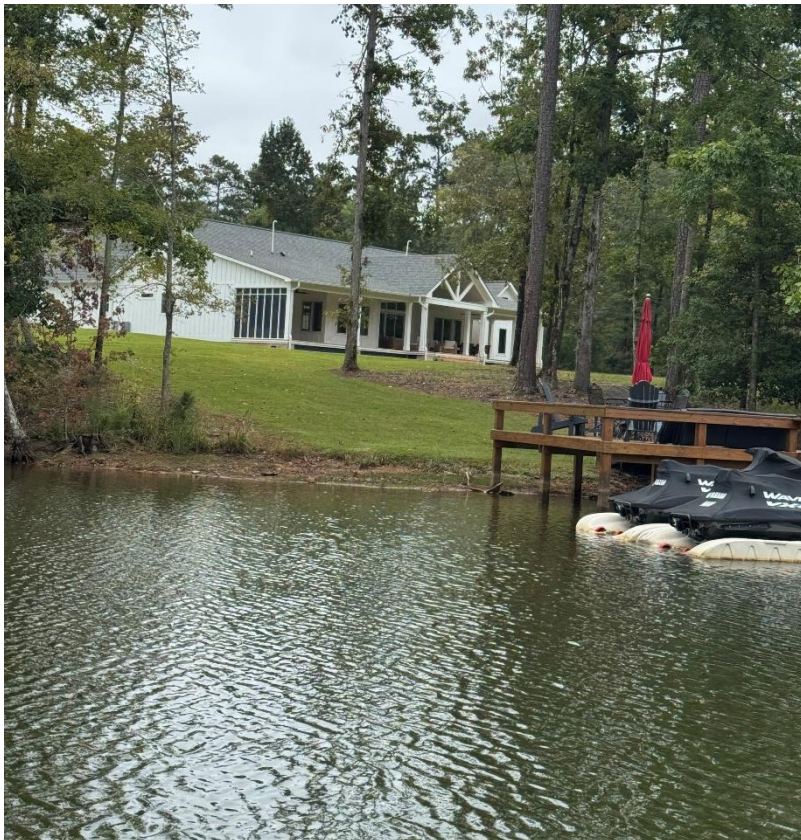
Figure 1

. Manicured lawn extends all the way to the lake's edge. Raking and mowing prevents establishment of natural vegetation that would protect the soil and prevent runoff of chemicals and fertilizers.

The first step in restoring a natural shoreline is to stop all blowing, mowing and removal of live plants from the 75-foot buffer zone. This will allow succession of natural vegetation to begin. Removal of exotic invasive plant species should be allowed within the area, and allowance should be made for removal of pines for control of bark beetle outbreaks (*Dendroctonus* and *Ips* beetles).
