FEDERAL ENERGY REGULATORY COMMISSION
Washington, D. C. 20426

Project No. 516-518 – South Carolina
Saluda Hydroelectric Project
Dominion Energy South Carolina, Inc.

July 29, 2024

Subject: Follow-up Compliance Inquiry – Buffer Zone and Riparian Management Plan

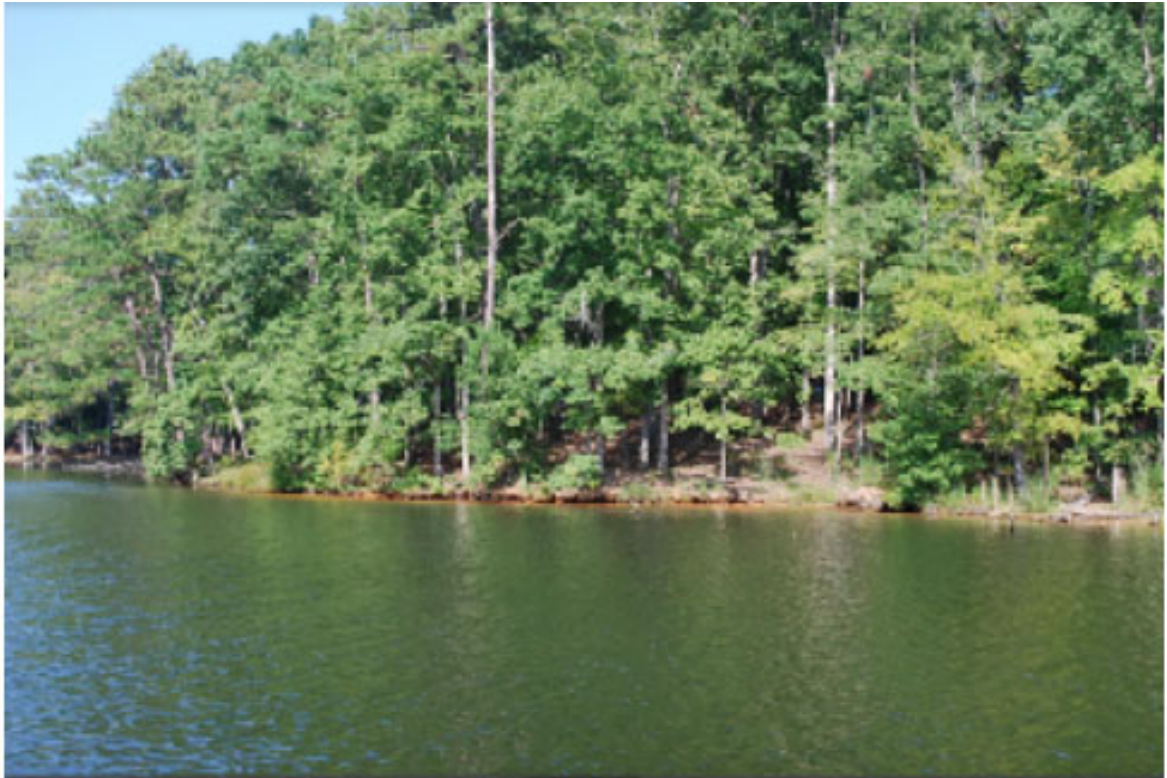
Lake Murray Watch provided pre- and post-brushing photographs of this shoreline, which appears to have slopes less than 2 to 1. Copies of these photographs are provided below for reference. Using publicly available historical aerial photography, we were unable to verify significant erosion at this location. If available, please provide photographs showing the erosion along this portion of shoreline which required armoring, verify the slope of the shoreline, and if relevant provide other factors which support the need to authorize rip rap stabilization in lieu of a vegetated solution. Additionally, provide information on the sediment control measures you required during this work, as the post clearing photograph appears to show considerable areas of bare earth where the understory has been cleared.

Shoreline adjacent to 288 Vinge Road before installing rip rap and brushing.

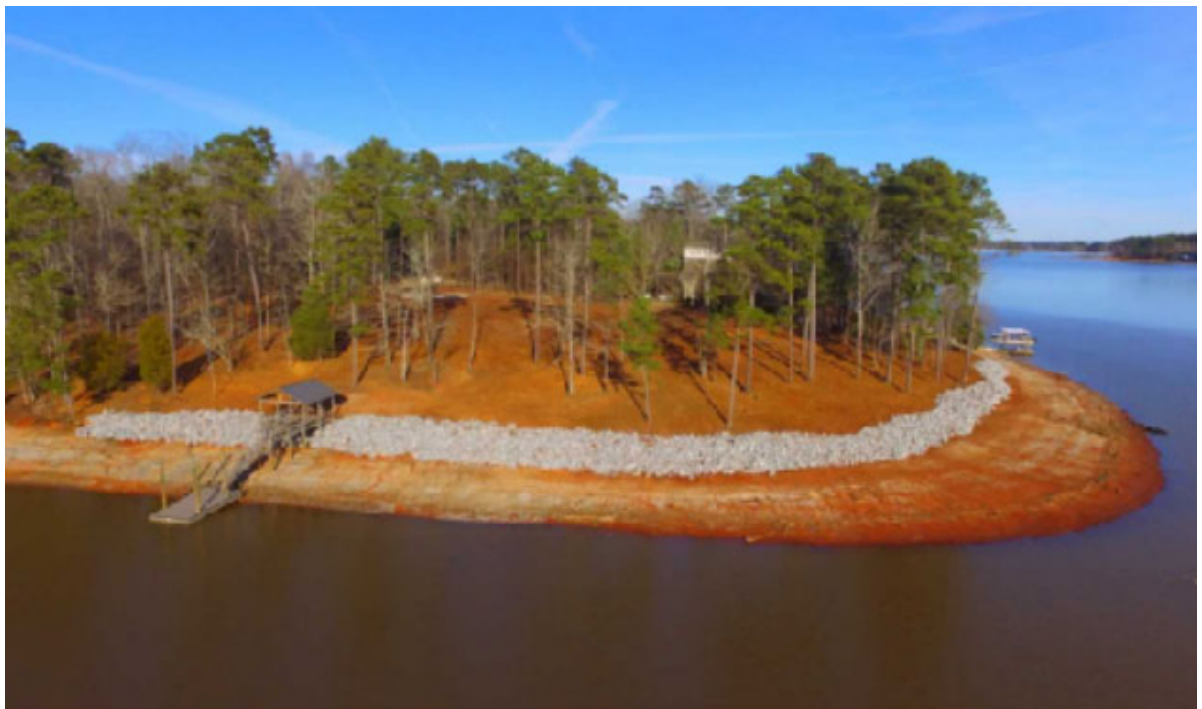
For Zone II areas (0-25 feet inland from the 360 elevation), the Buffer Plan states absolutely no removal of trees other than dead or diseased specimens is permitted in this zone and removed trees must be replaced as needed to meet the spacing requirement. Please provide the justification for the removal of virtually all vegetation, including trees, in the Zone II portion of the buffer zone at this location and why you have not enforced the requirement for replanting in this area. While the Buffer Plan allows for selective thinning in Zone III of the buffer zone to remove undesirable or dead trees and shrubs, the photographs suggest that more than diseased or dead trees have been removed. Please provide justification for the number of trees and other vegetation removed in the Zone III portion of the buffer in this area.

Shoreline adjacent to 288 Vinge Road after installing rip rap and brushing.

4. The extension of the buffer zone along the shoreline adjacent to the lot adjacent to the Randy and Myra Moore and Scott Lominick parcels was a requirement of the 2004 Order. However, the post-brushing photograph shows a diminished buffer zone which appears to open views to Lake Murray for the benefit of future construction on the adjacent parcel. Please provide an explanation why many of the trees and nearly all understory vegetation was removed from the buffer zone and if there are plans to restore the buffer zone to its previous condition. additionally, please provide an explanation why machinery and or tracked equipment appears to have been allowed below the 360 elevation and within the vegetative buffer zone.
