September 24, 2024

Subject: Dominion Energy South Carolina, Inc.
Saluda Hydroelectric Project, P-516-518
Response re: Compliance Inquiry – Buffer Zone and Riparian Management Plan

Attachment 2: Harbour Watch 16 Properties Photos and Status

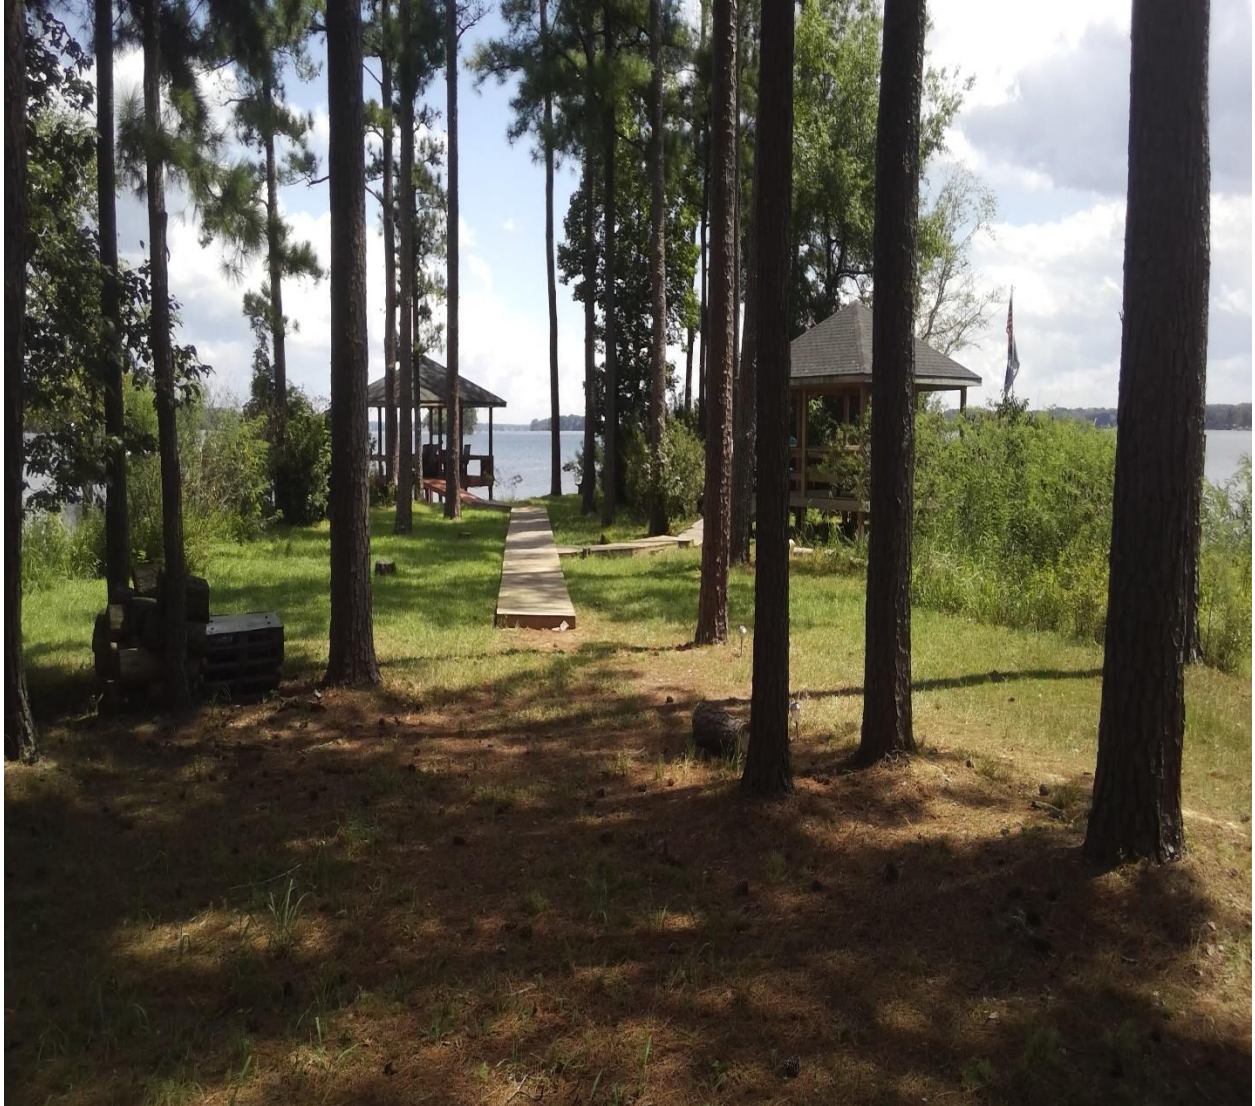
116 and 120 Anchorage Ln. DESC agreed to let walkway stay due to low area holding water when it rains. This allows the property owners get to and from their dock safely.

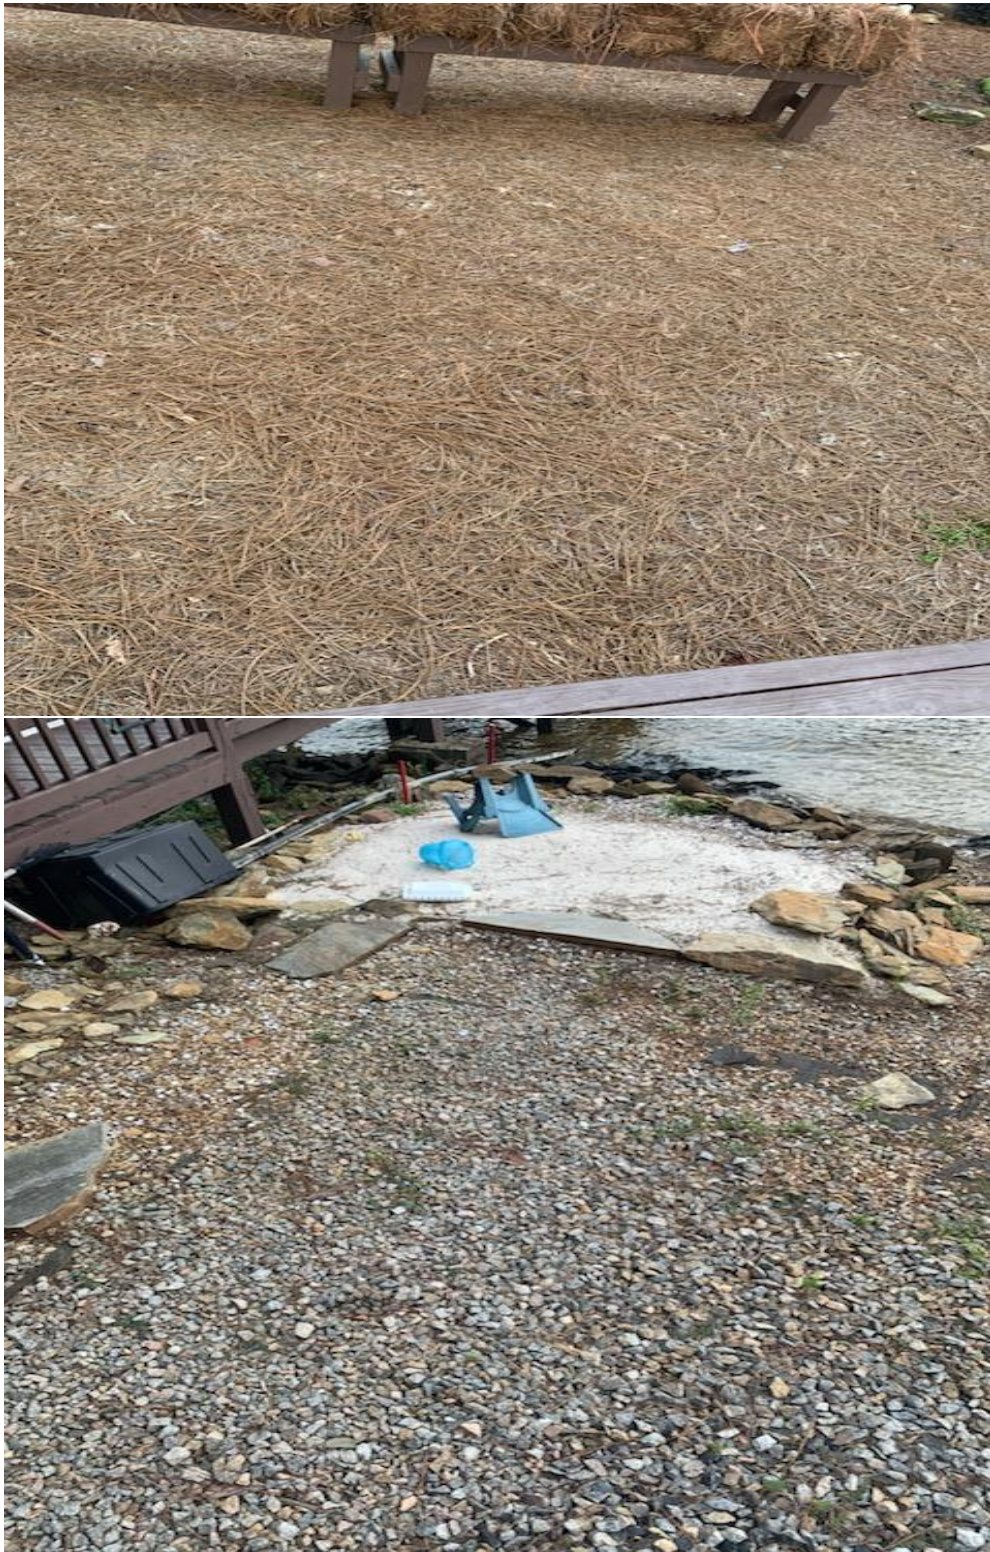
128 Anchorage Ln. Pavers removed and brick fireplace removed.

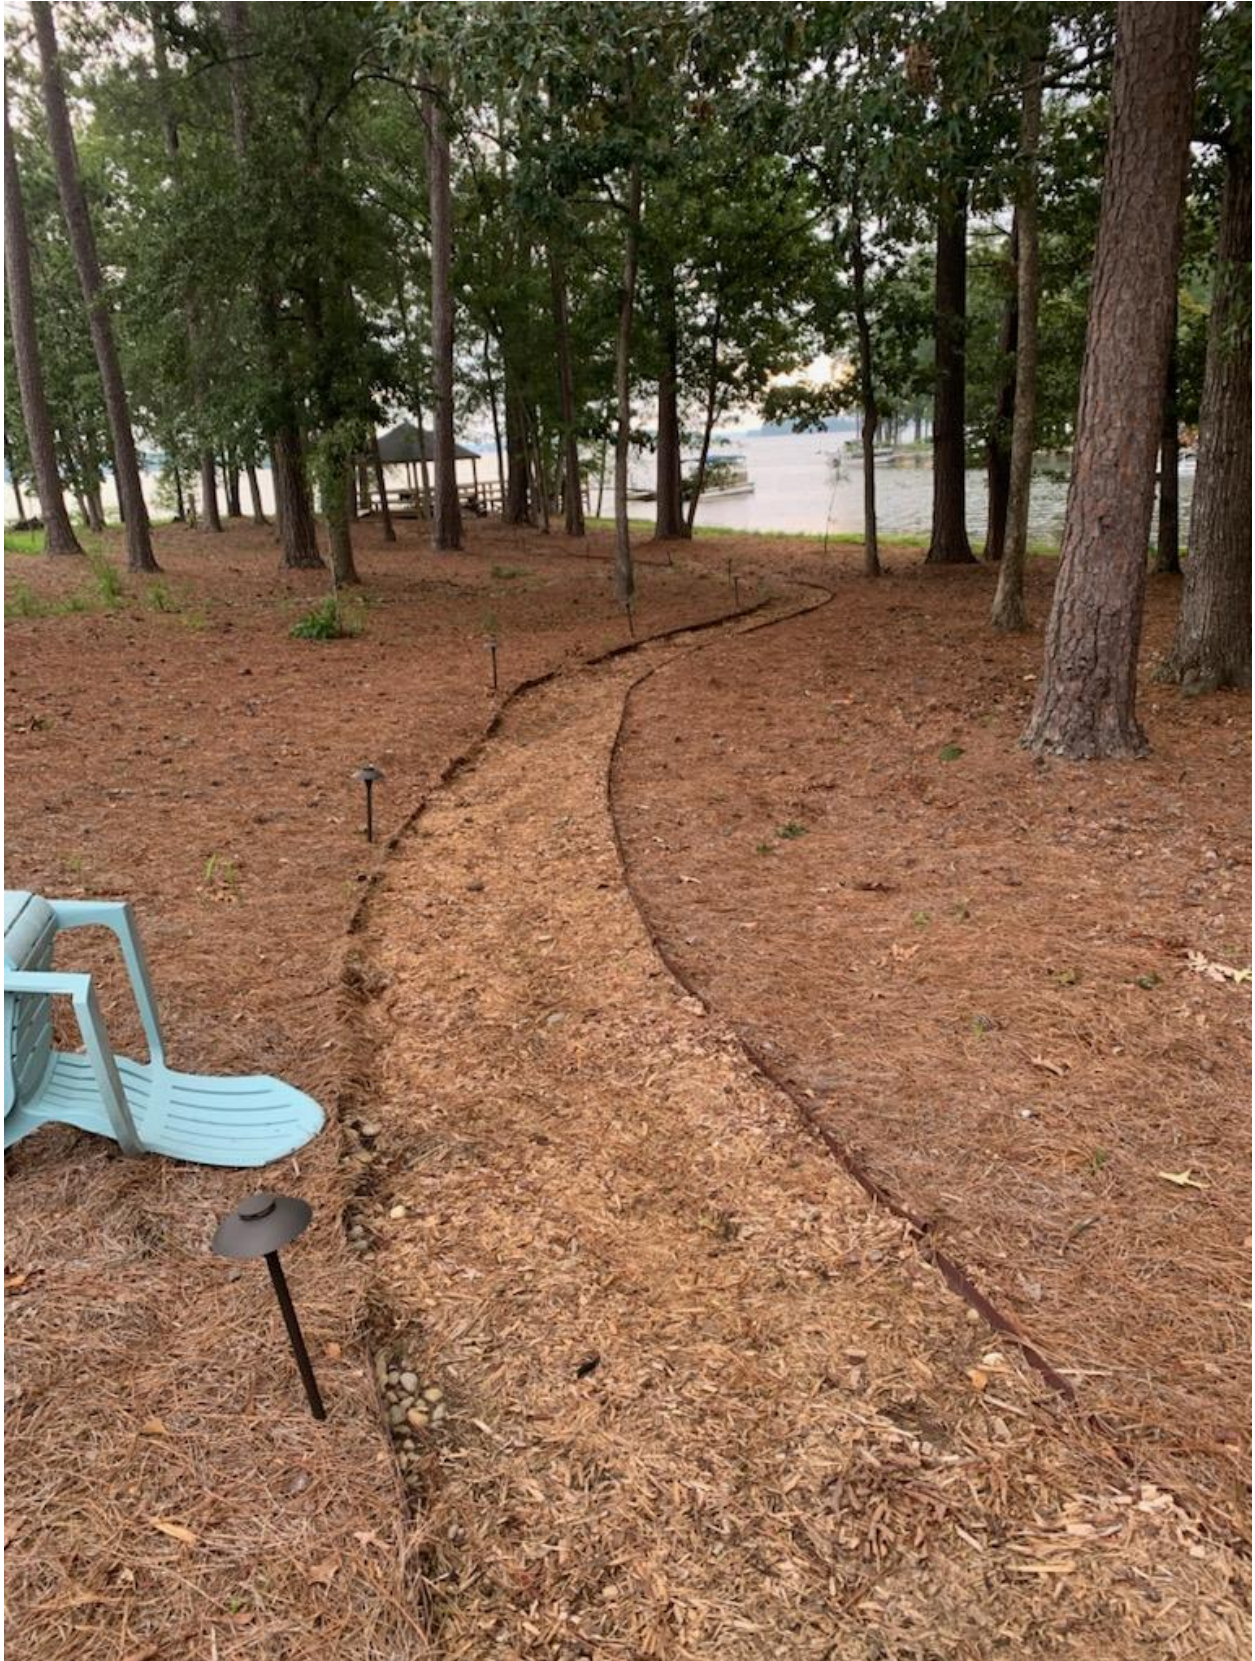
104 Osprey Pt. DESC is still working with homeowner to remove edging rails.

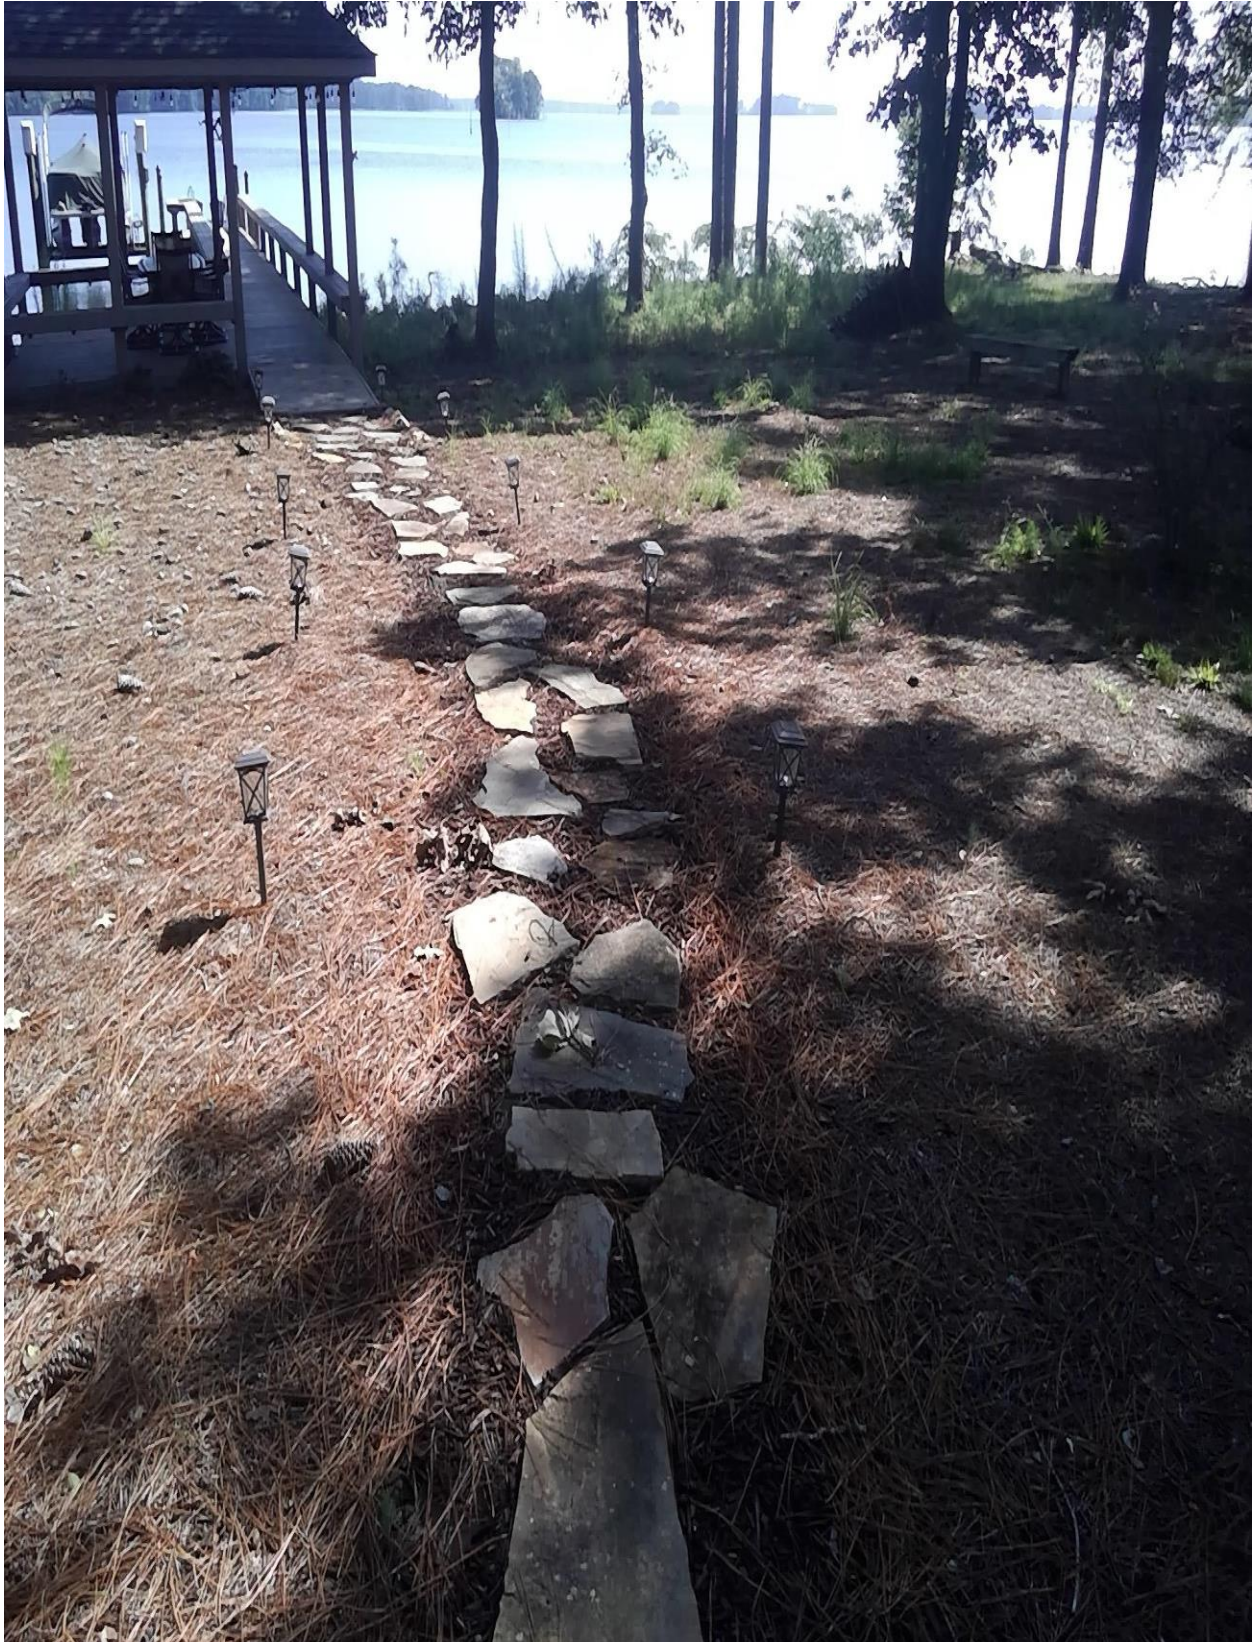
108 Osprey Pt. Path violation is complete. Pinestraw and natural flagstone added over black fabric.

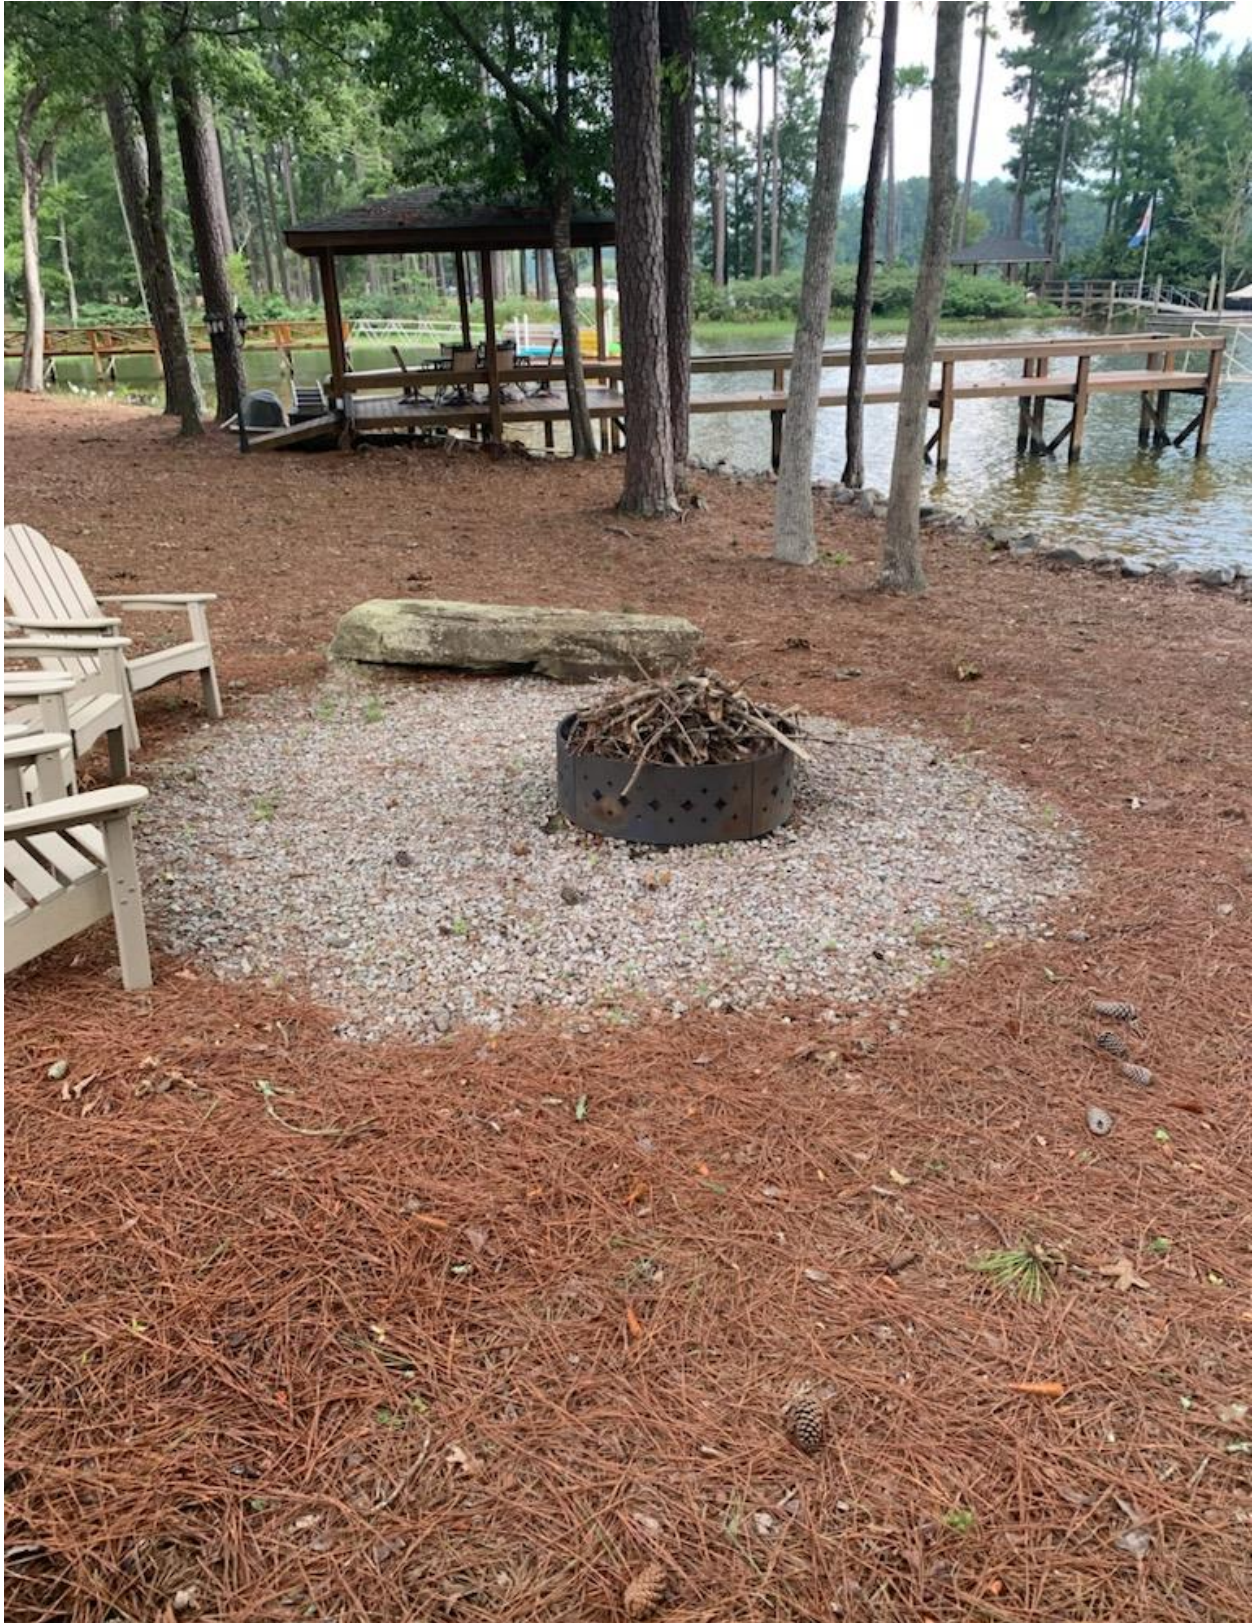
109 Osprey Pt. DESC is still working with the property owner to remove gravel area.

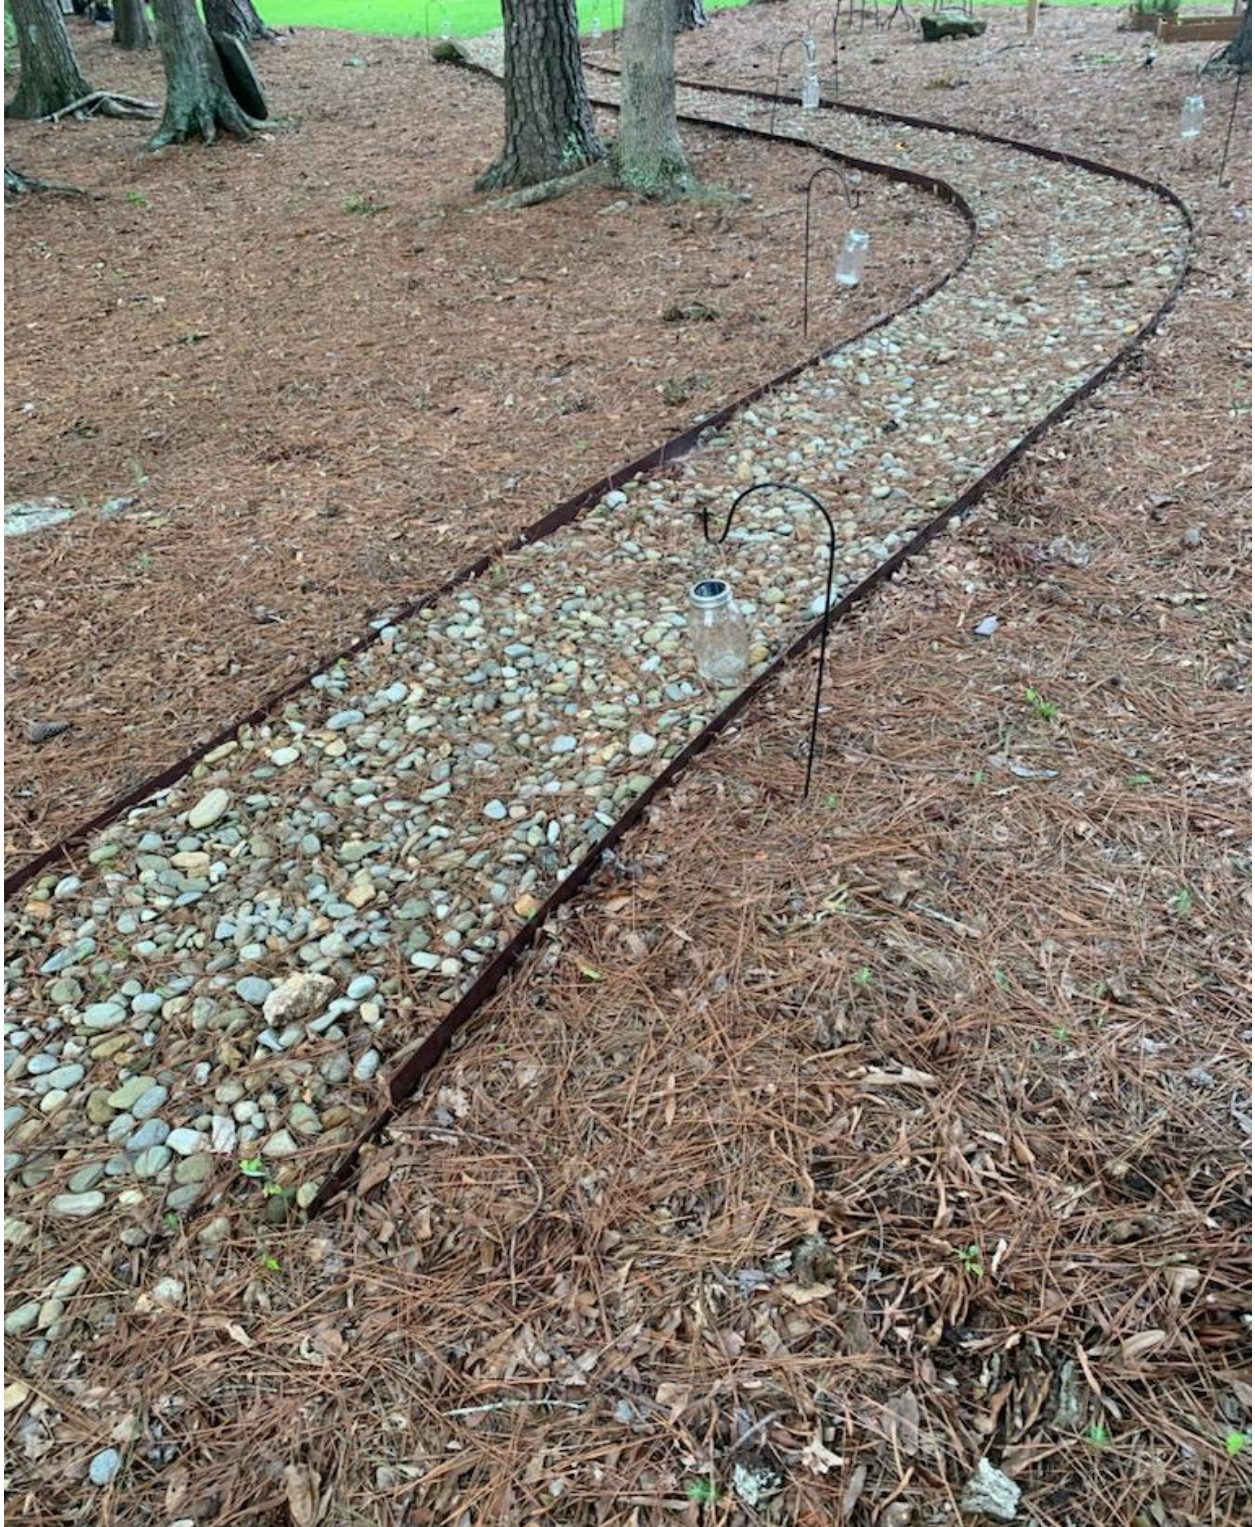
141 Windjammer. DESC is still working with the property owner to remove the railing on the path. The walkway material is allowed to stay due to the natural appearance of the walkway.

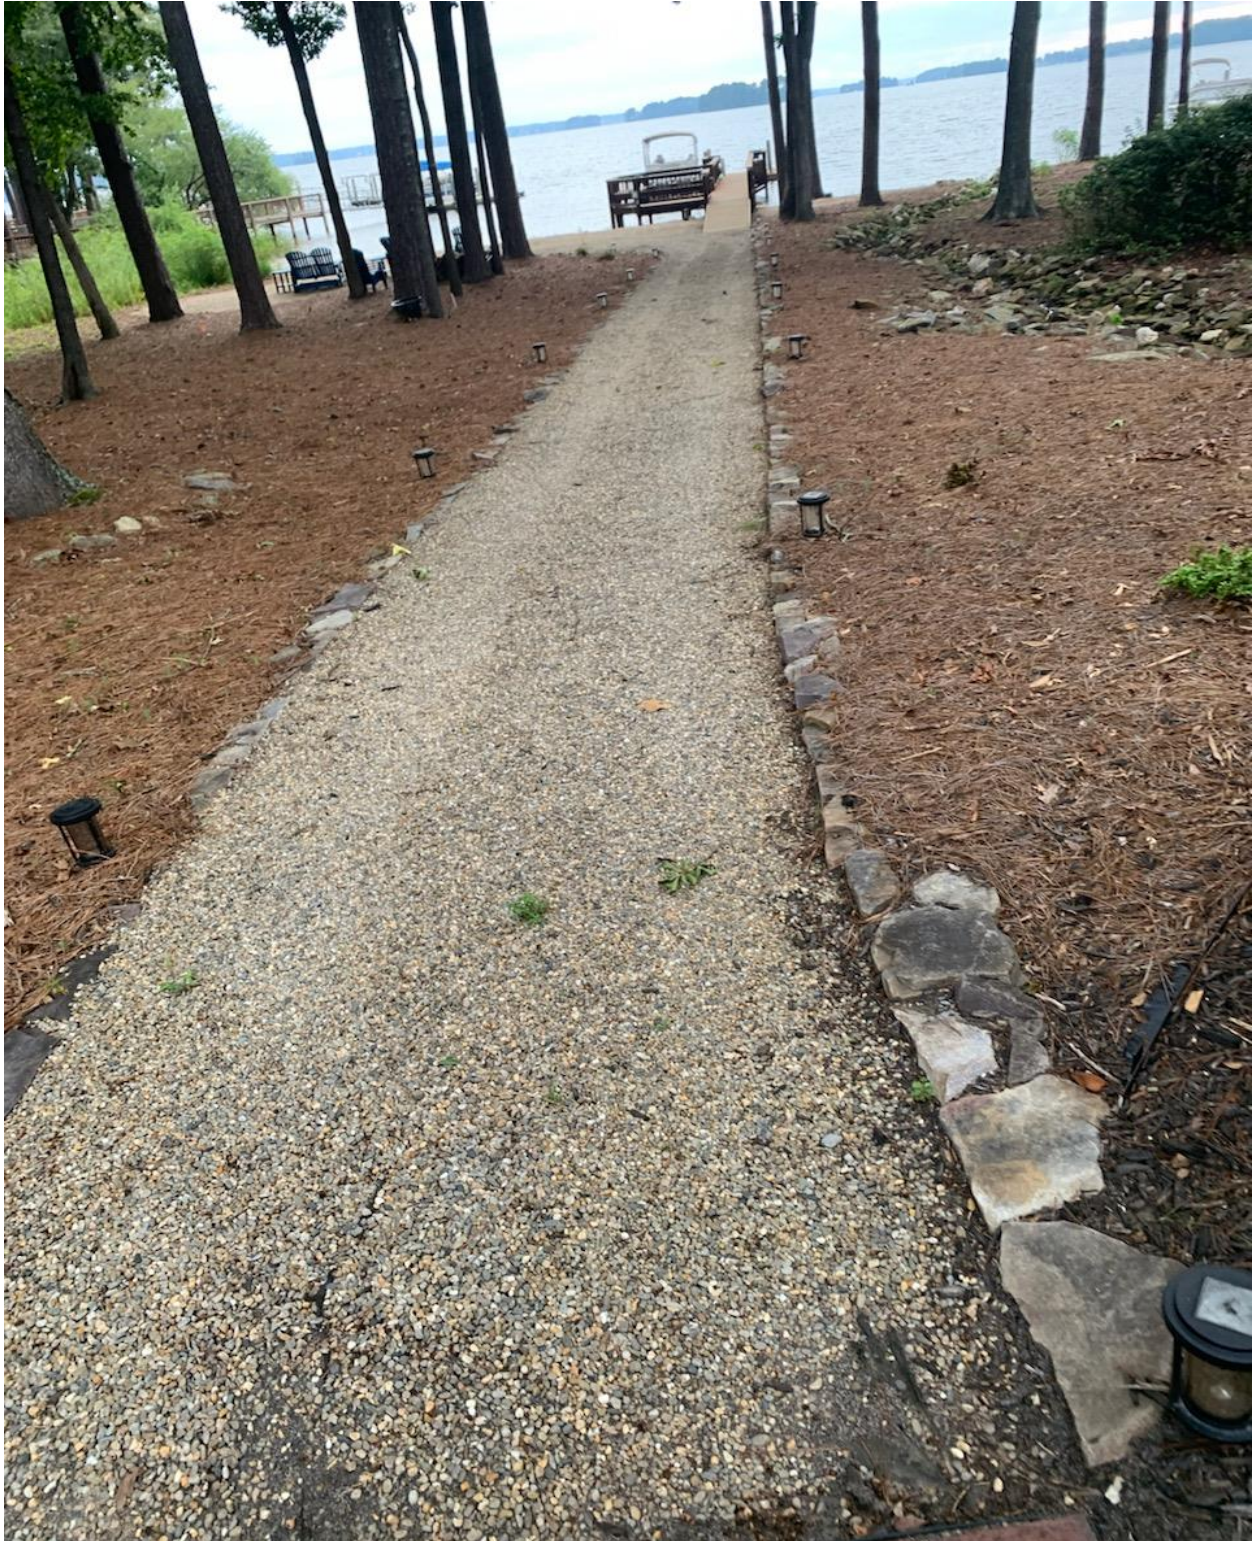
129 Breezy Pointe Ln. Walkway material allowed to stay due to the natural appearance of the walkway.

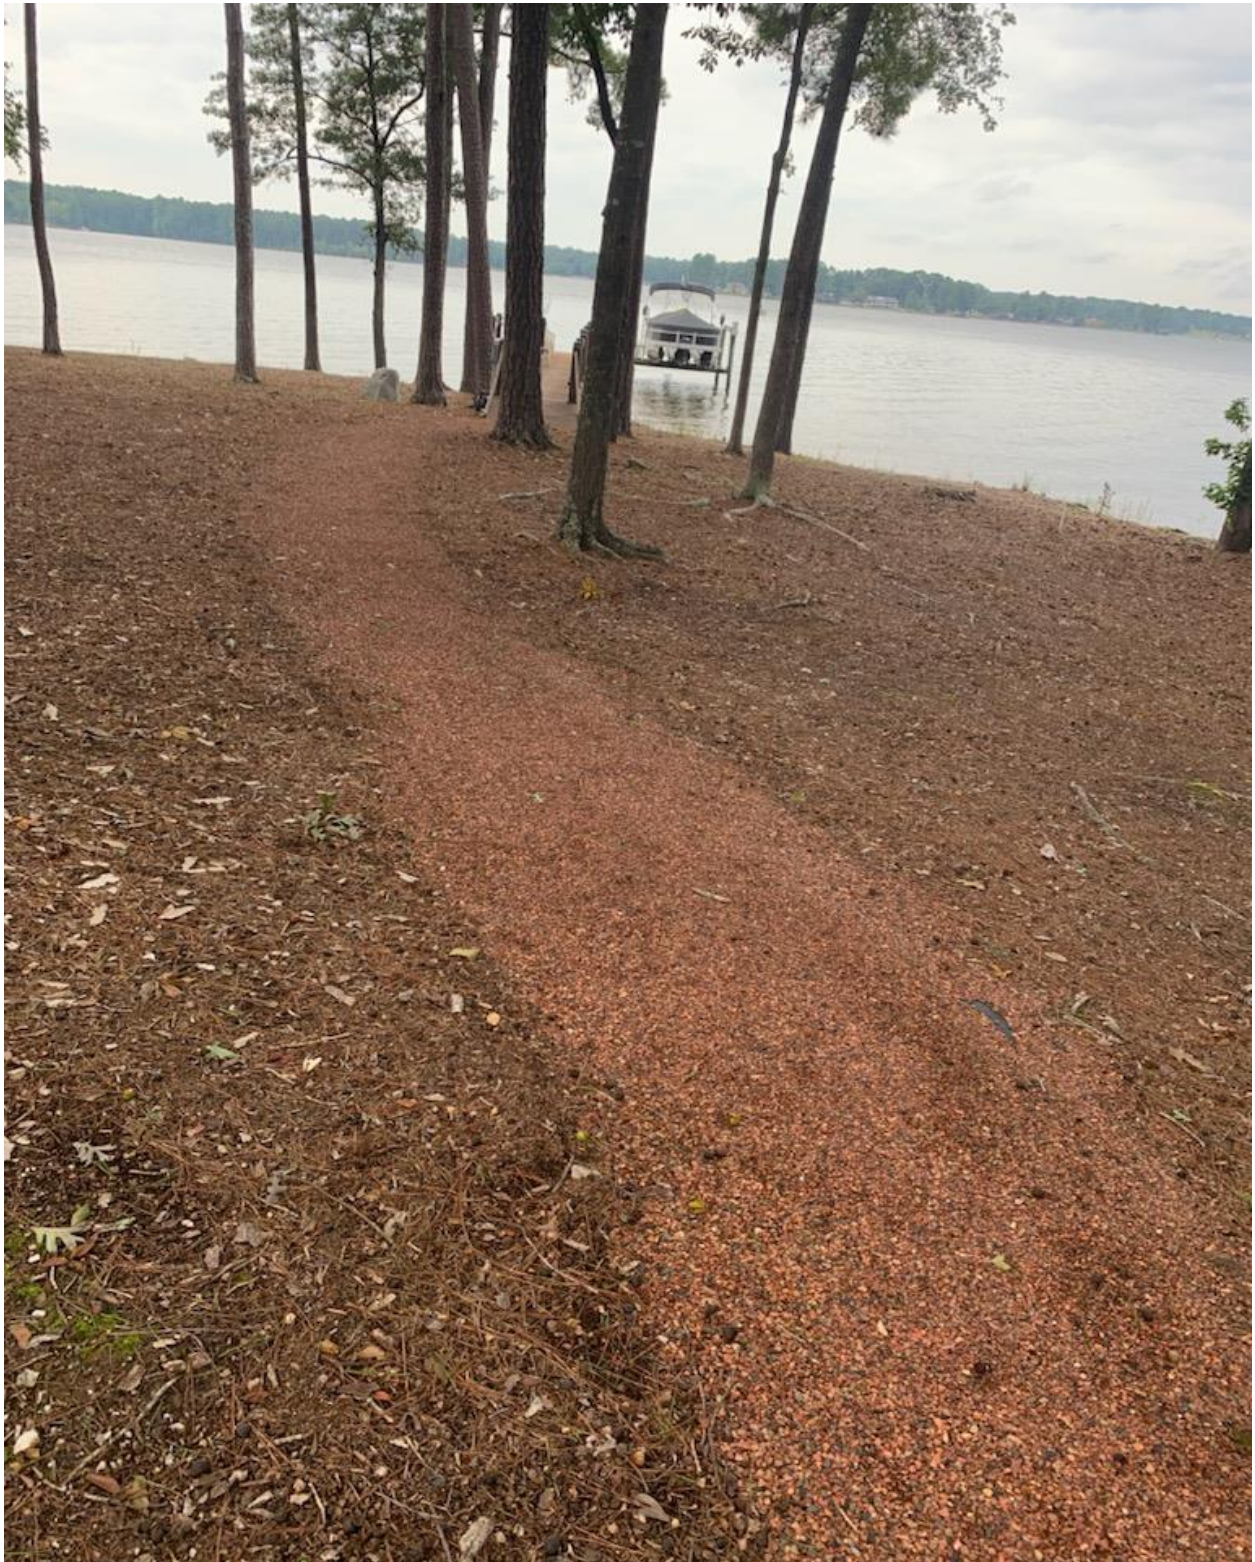
132 Breezy Pointe Ln. Edging rails are removed.

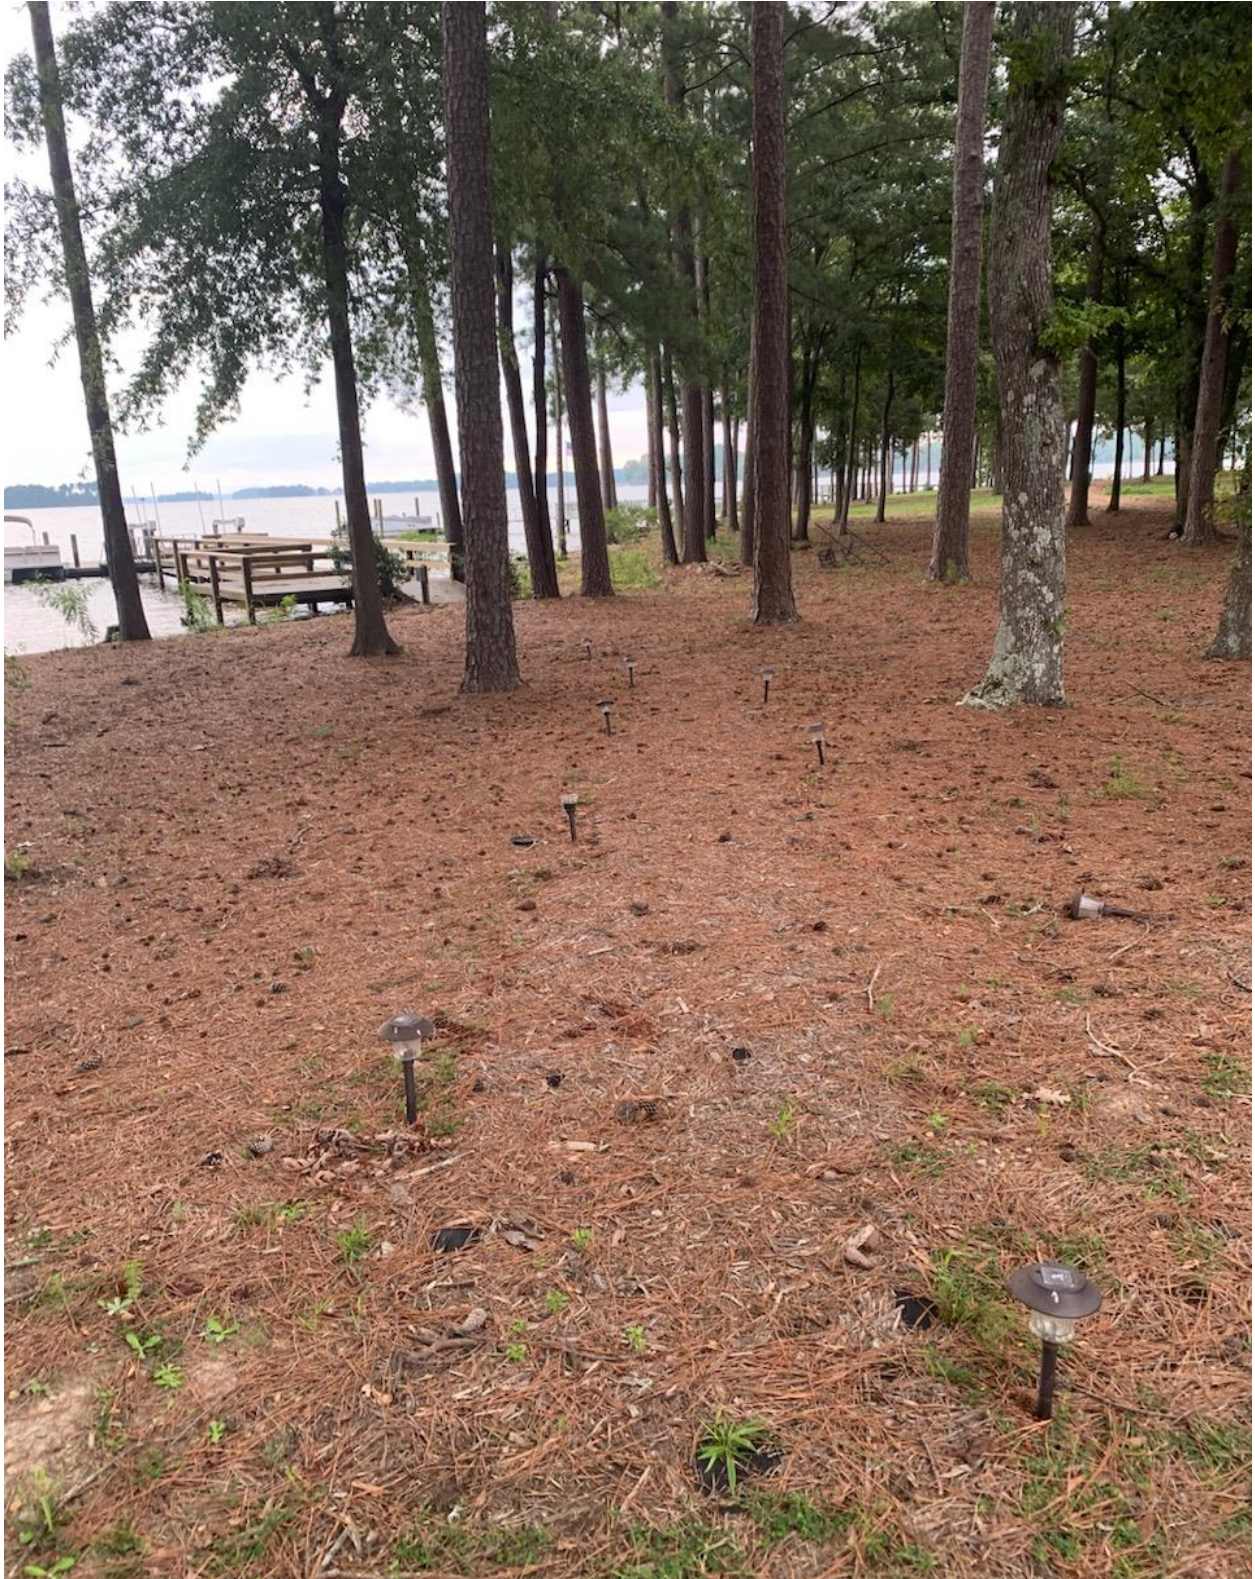
133 Breezy Pointe Ln. Water Fountain and path removed.

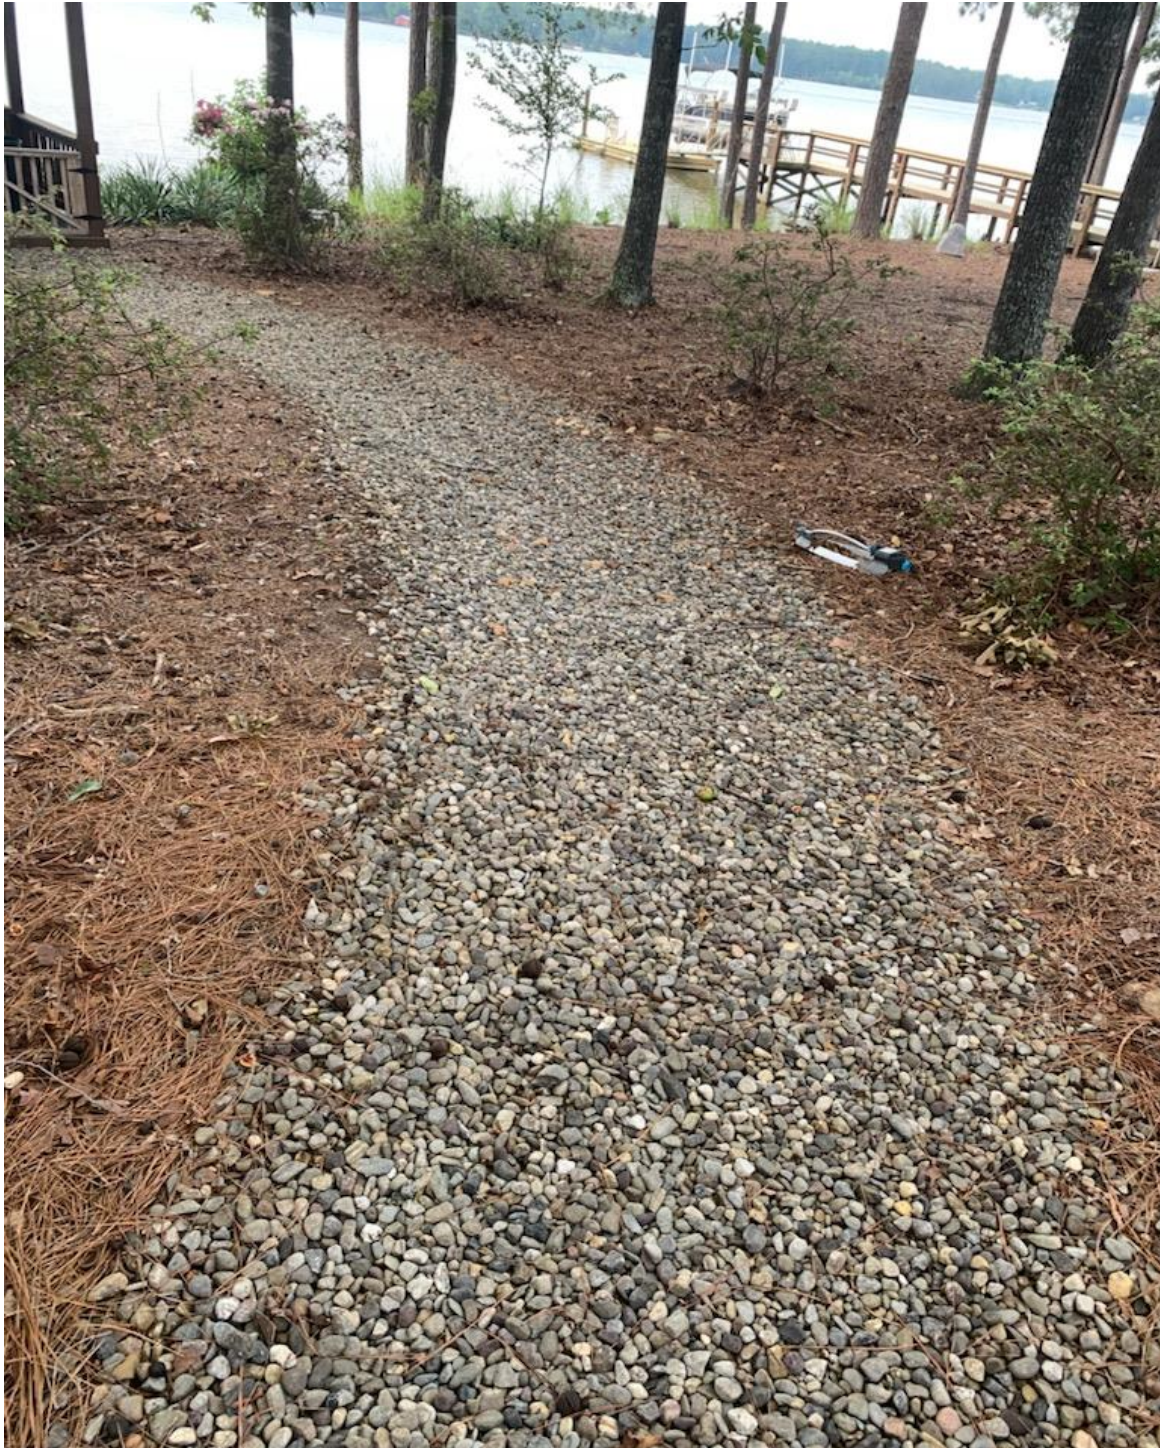
140 Breezy Pointe Ln. Rails on the path removed and walkway material allowed to stay due to the natural appearance of the walkway.

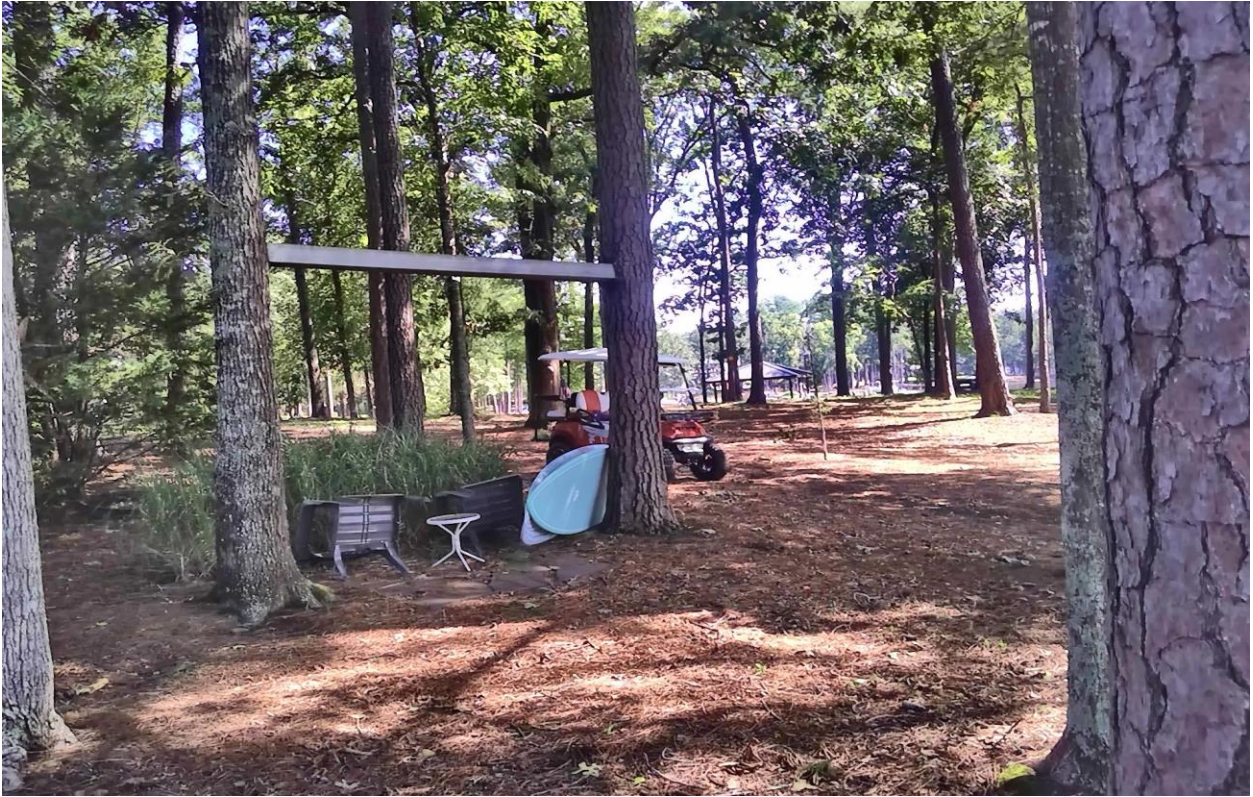
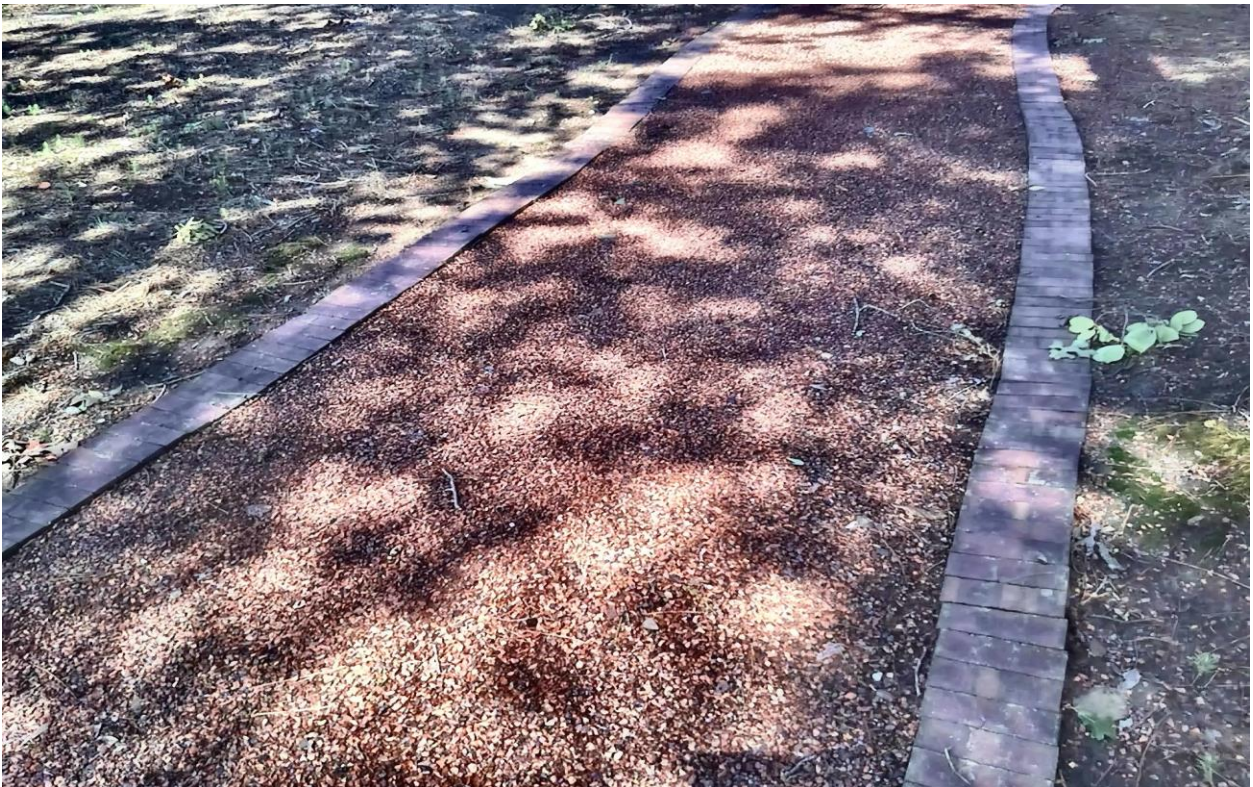
112 Harvest Moon. Walkway material allowed to stay due to the natural appearance of the walkway.

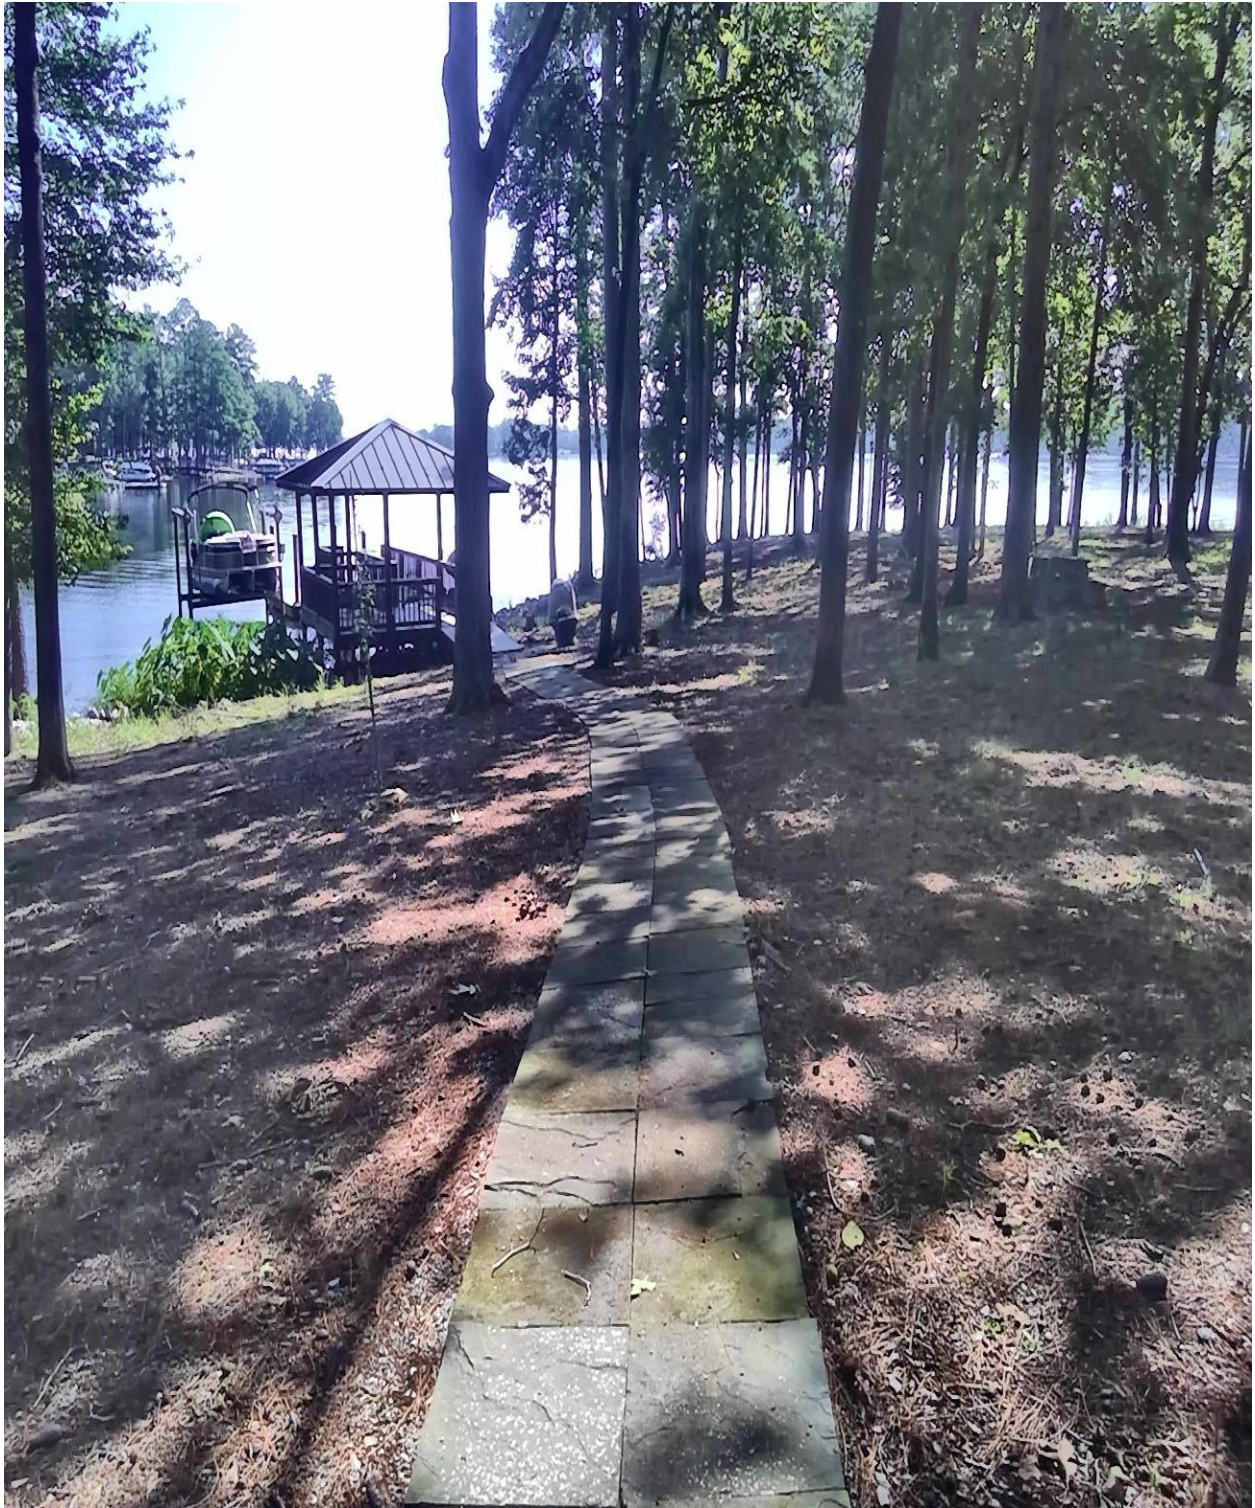
120 Harvest Moon. Rails removed. Walkway material allowed to stay due to the natural appearance of the walkway.
