September 24, 2024

Subject: Dominion Energy South Carolina, Inc.
Saluda Hydroelectric Project, P-516-518
Response re: Compliance Inquiry – Buffer Zone and Riparian Management Plan

Attachment 2: Harbour Watch 16 Properties Photos and Status

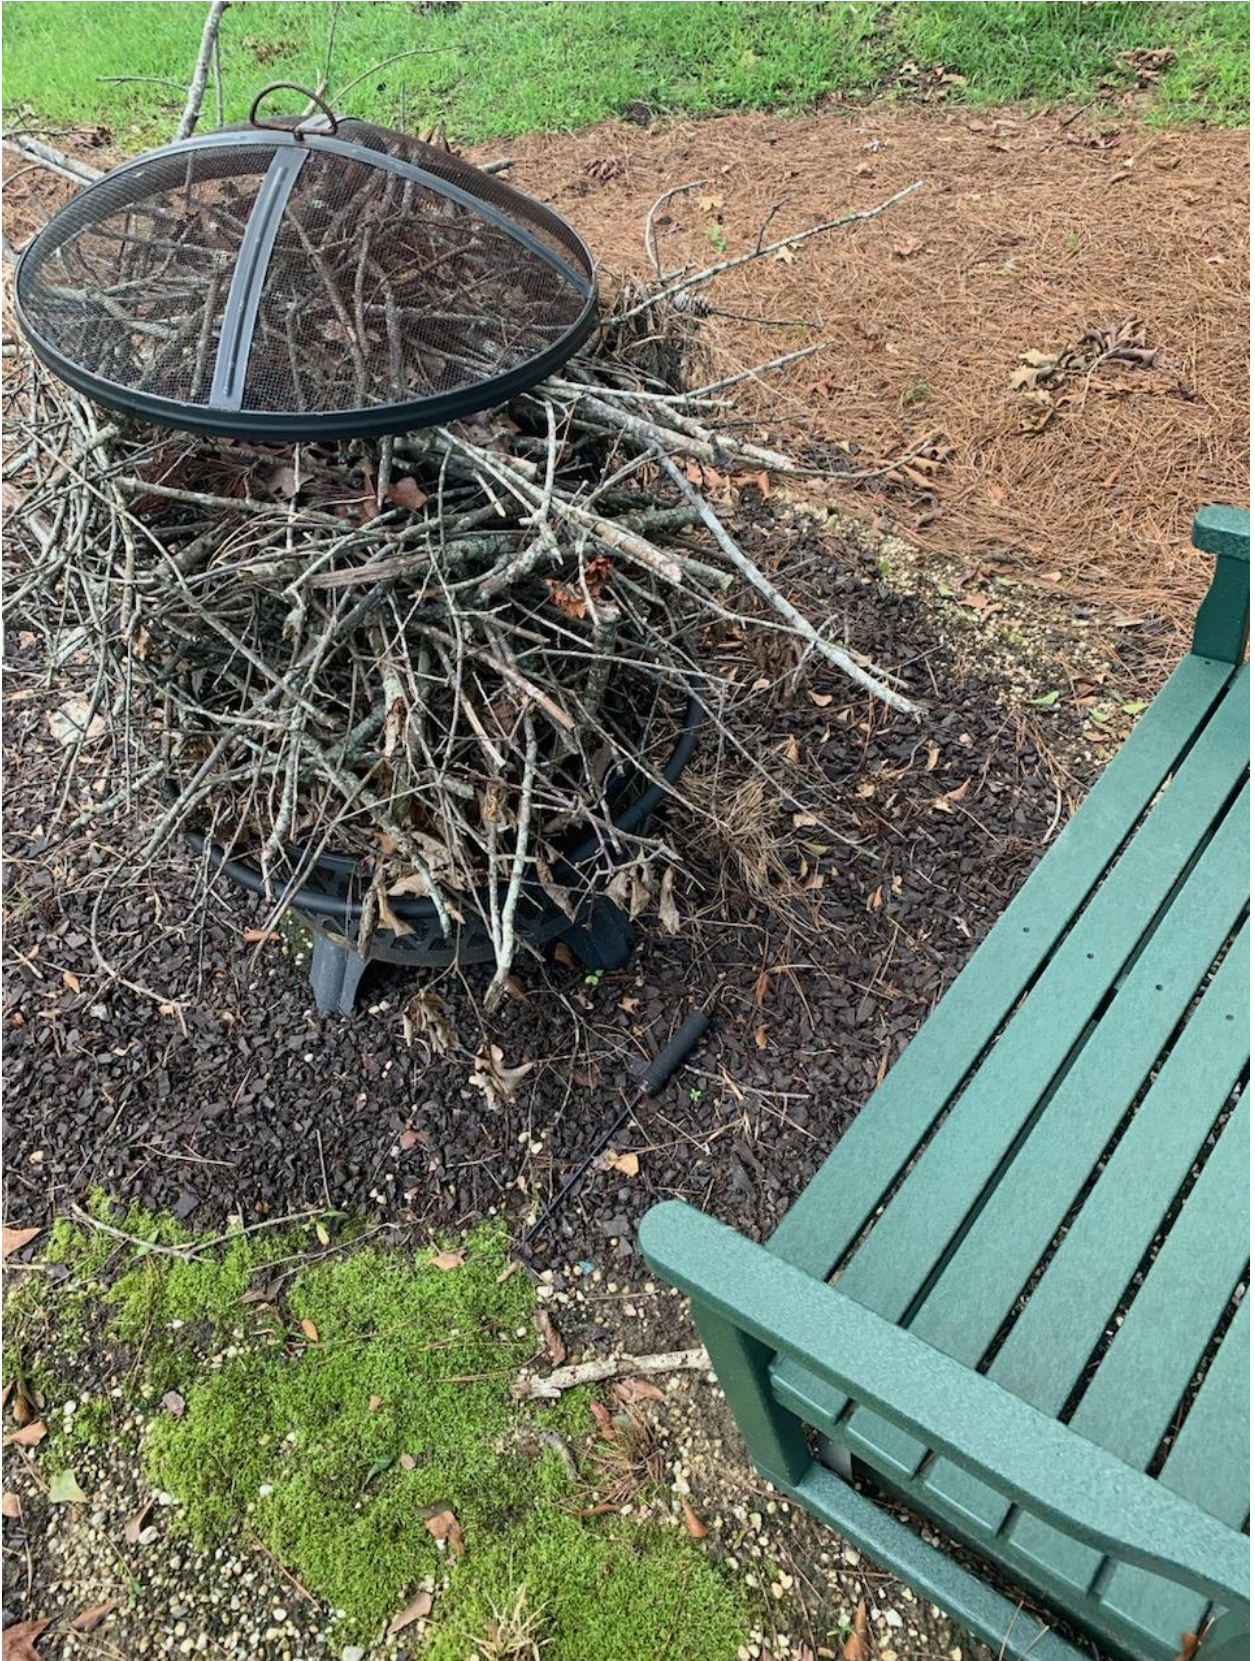
140 Harvest Moon. Pavers Removed.

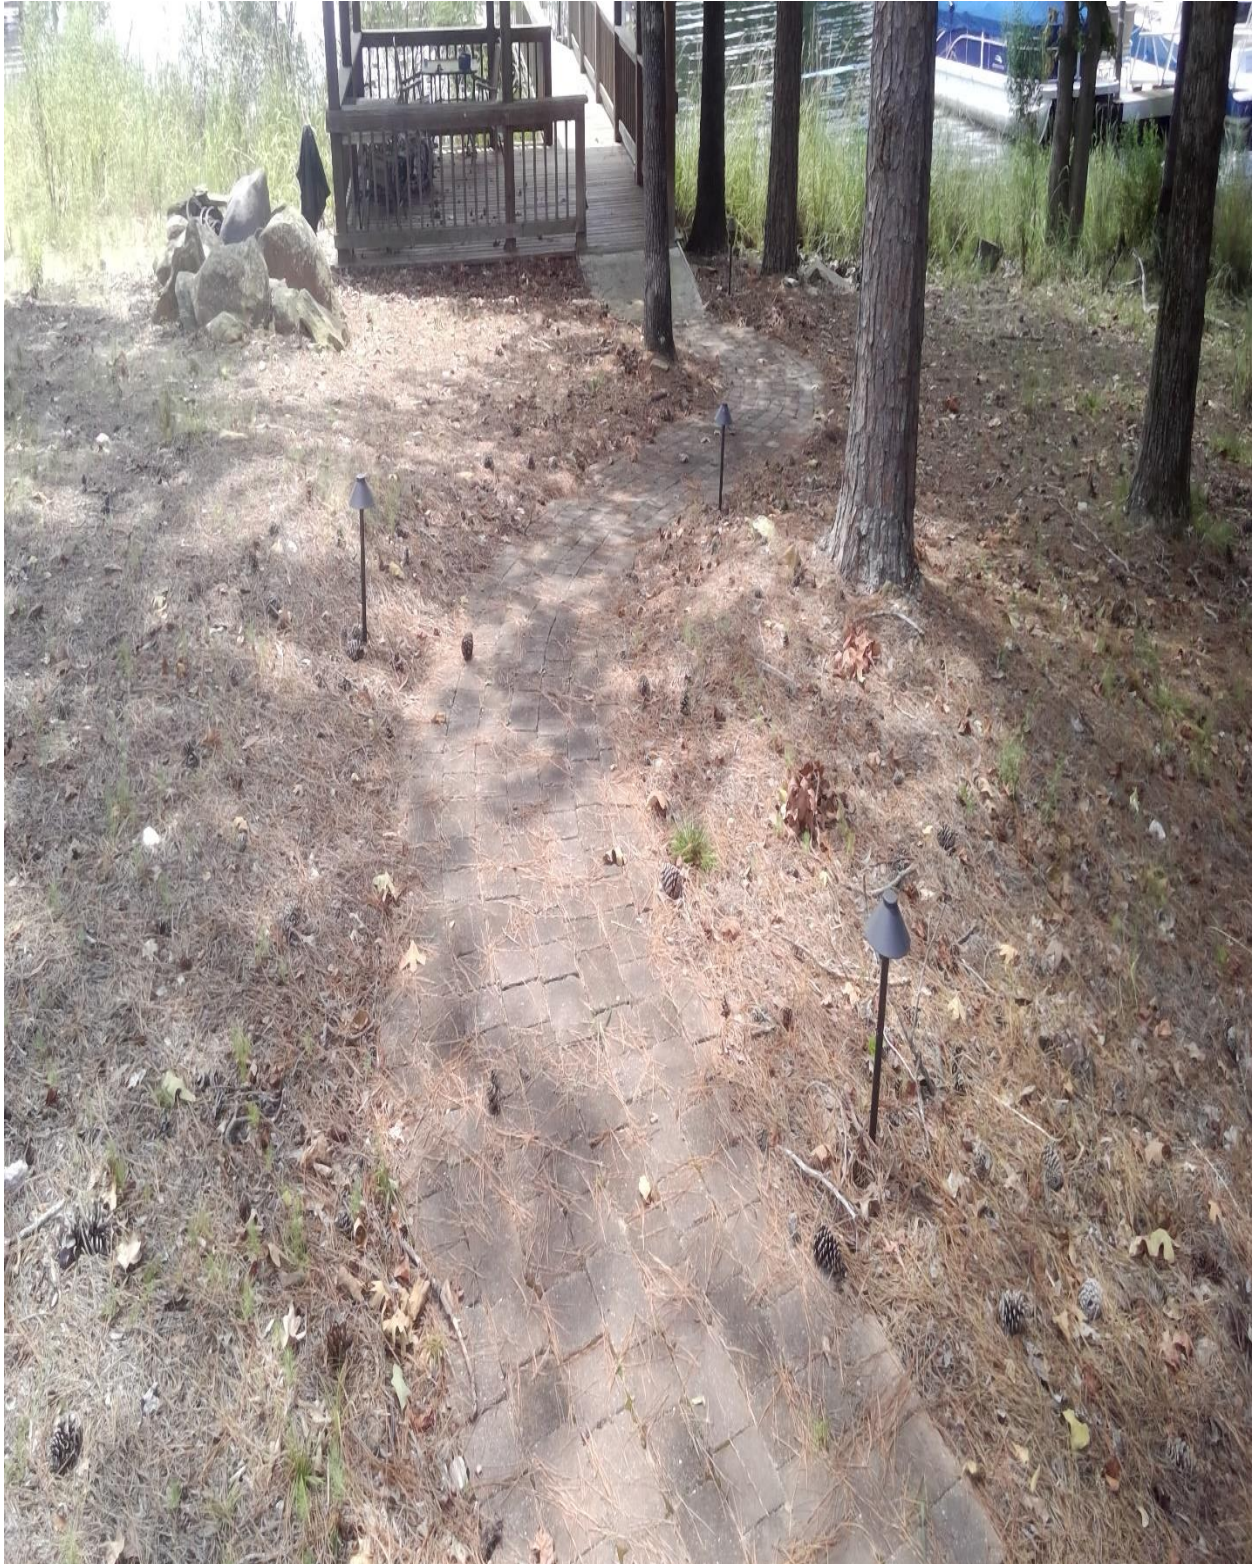
156 Harvest Moon. Walkway material allowed to stay due to the natural appearance of the walkway.

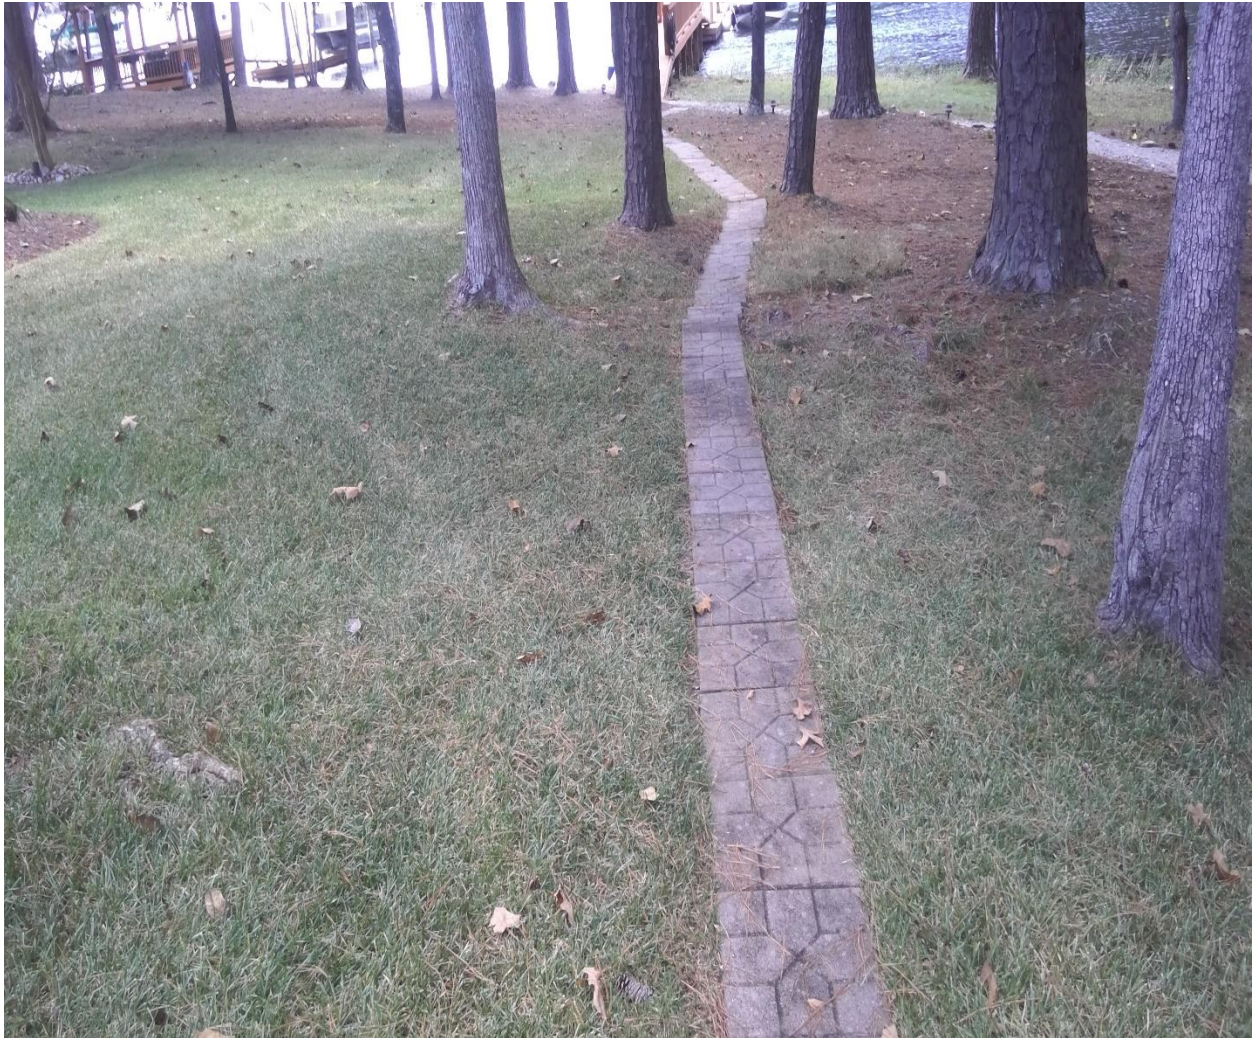
152 Summer Breeze. Walkway material allowed to stay due to the natural appearance of the walkway.

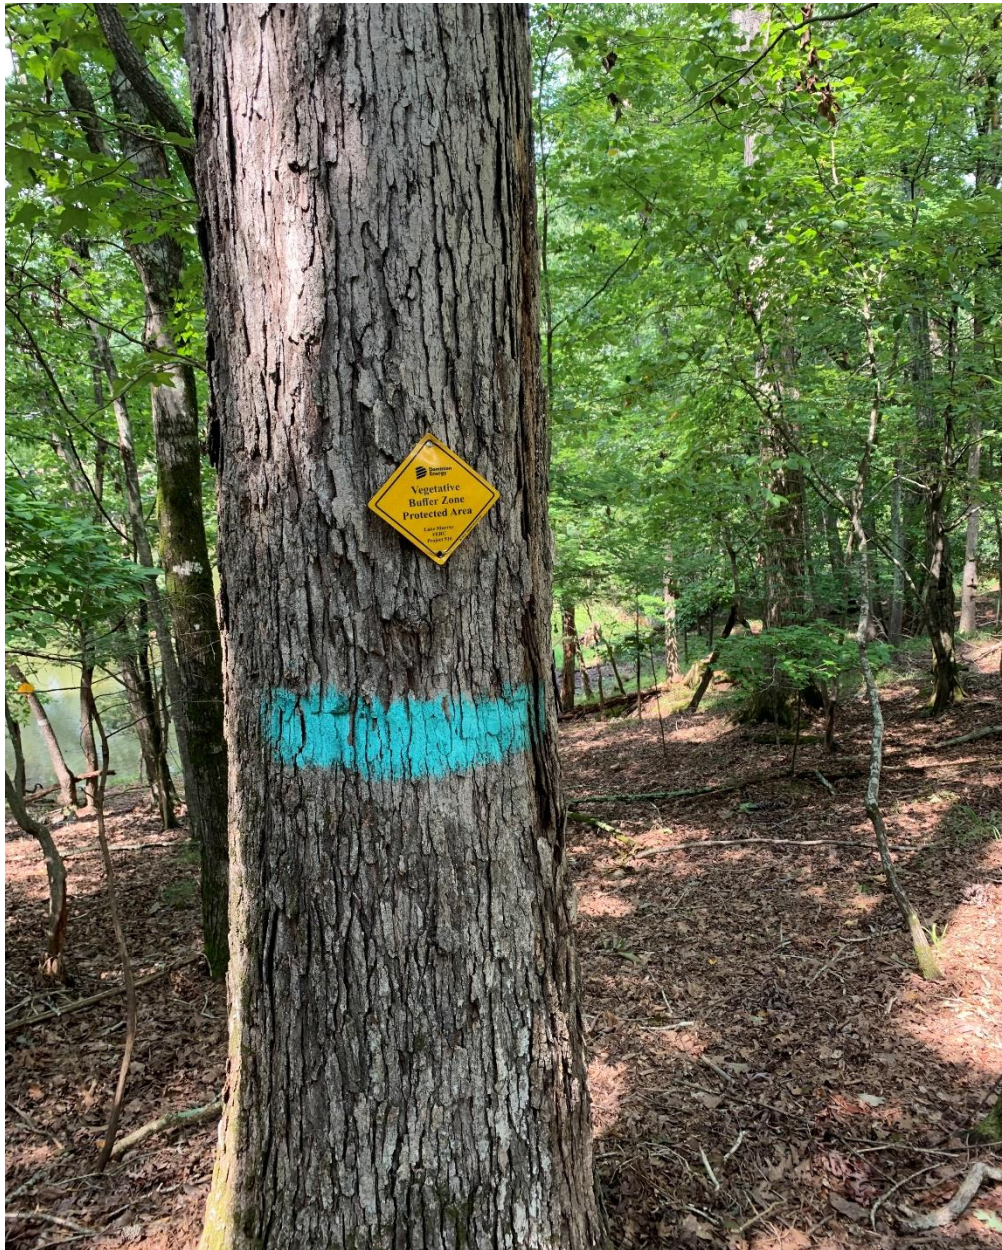
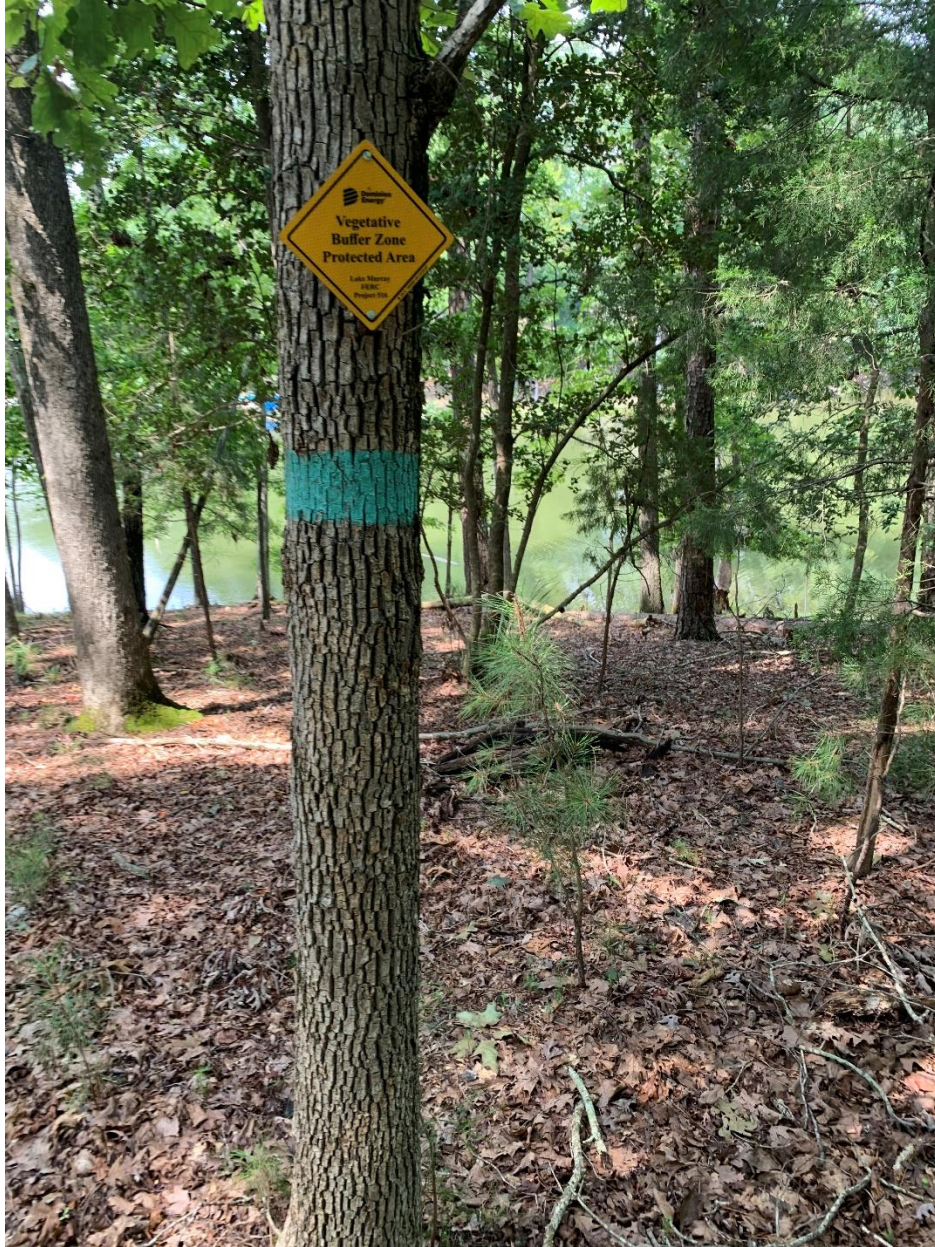
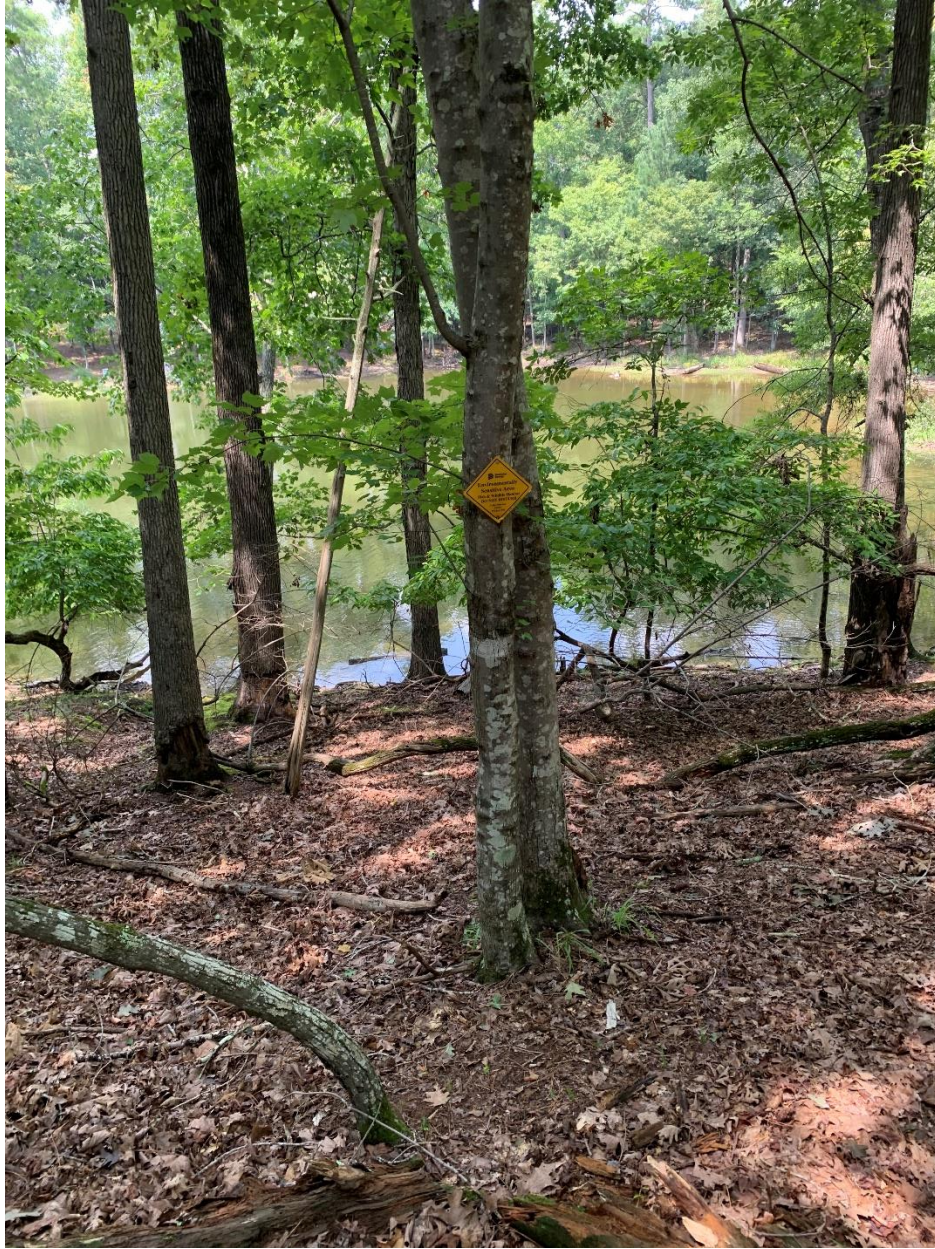
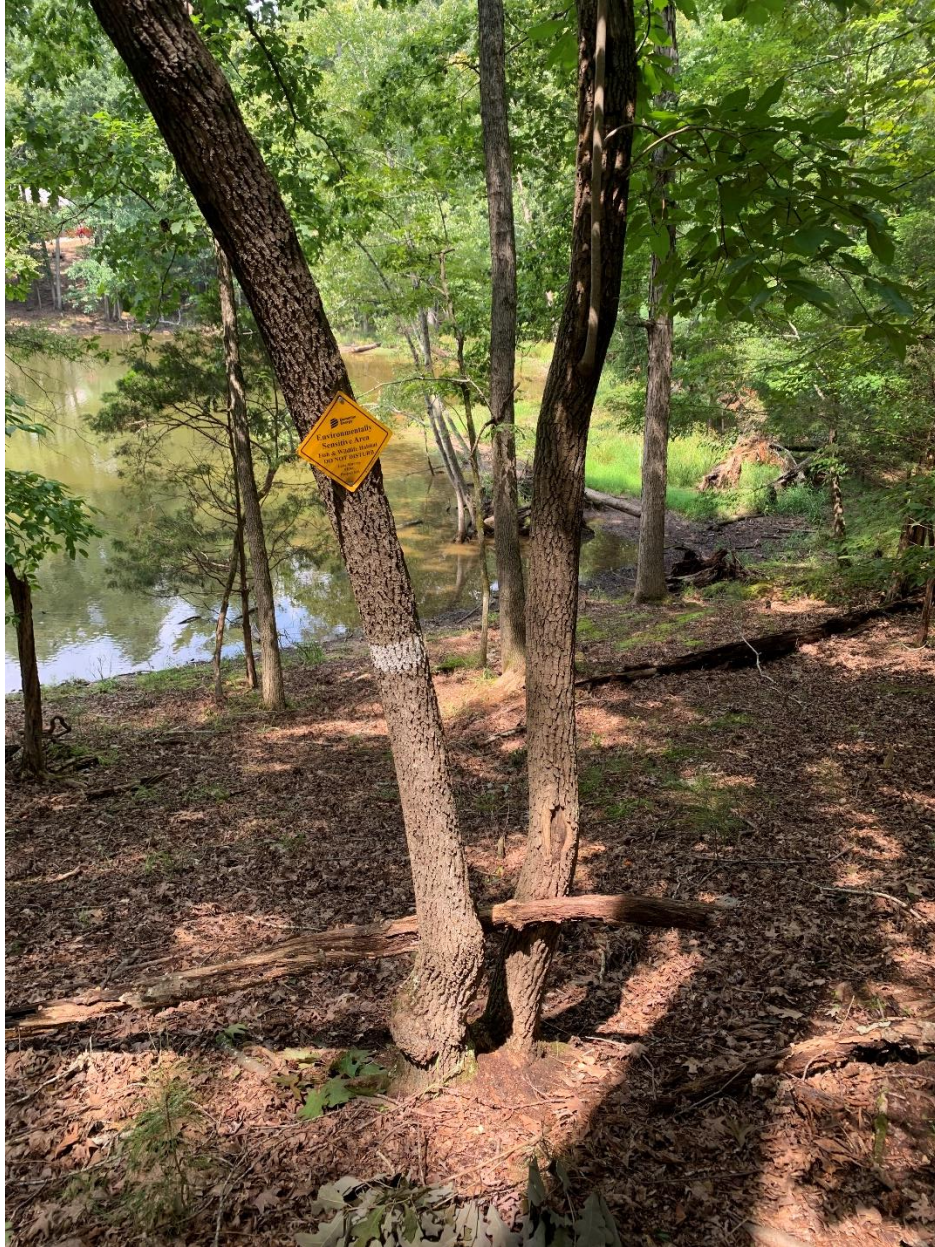
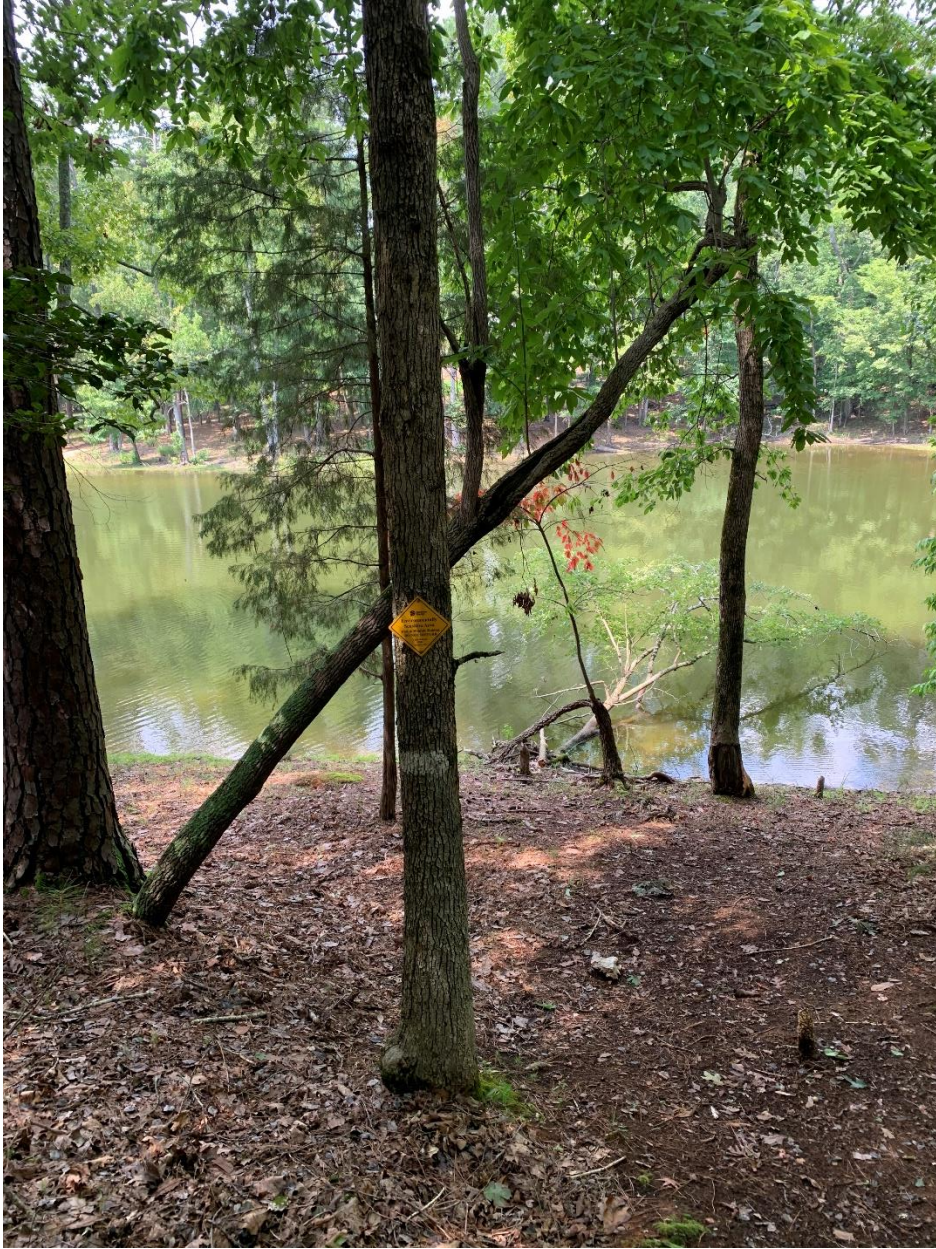
See the next 5 pictures for Moore and Lominick tract signed according to 2004 order.

Response: The 25' non-disturbance buffer was inadvertently not marked and signed when the property was originally sold but not immediately developed. After several years had passed, DESC mistakenly issued a limited brushing permit for the non-disturbance portion of this buffer. To correct this, the buffer has been planted with trees using the guidelines in the buffer zone and riparian management plan. The buffer has been signed according to the 2004 Order.

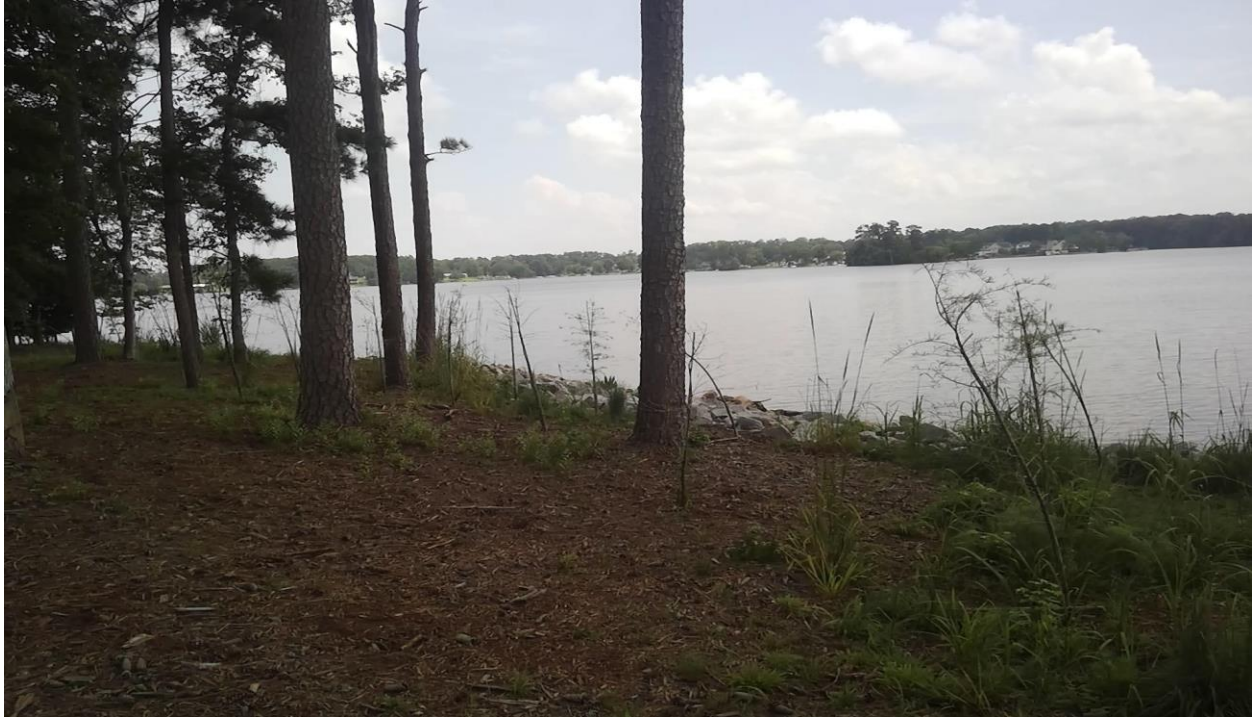
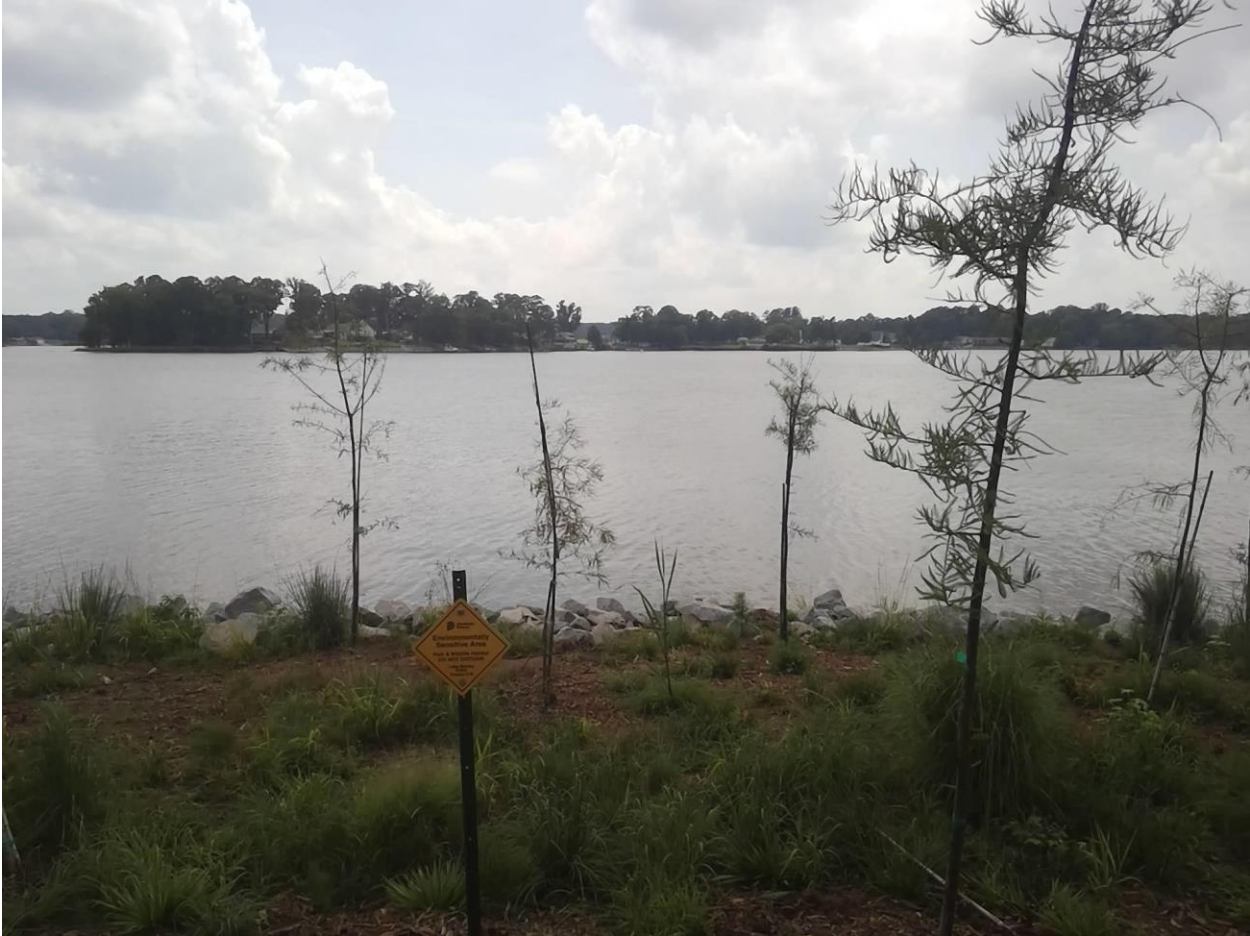
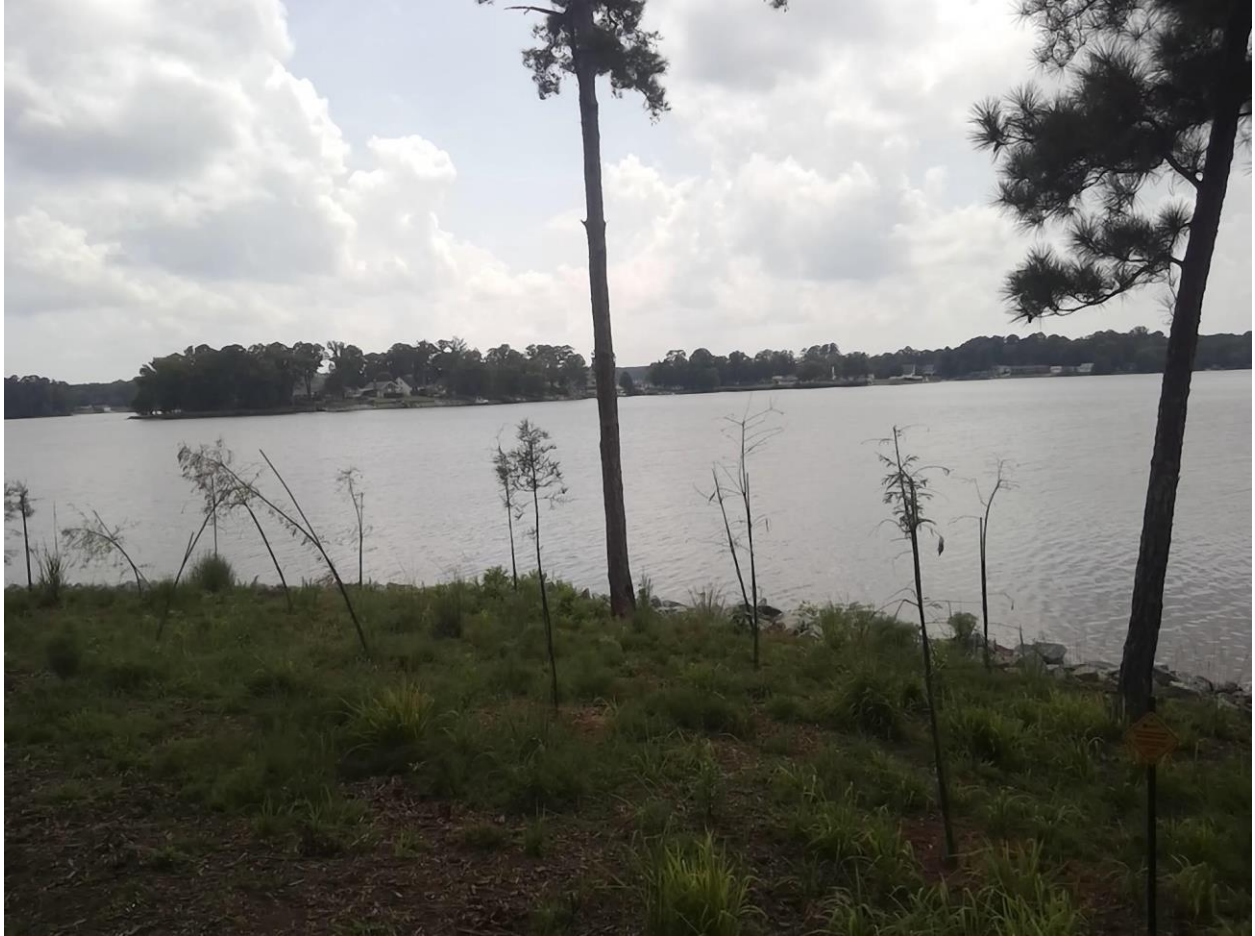
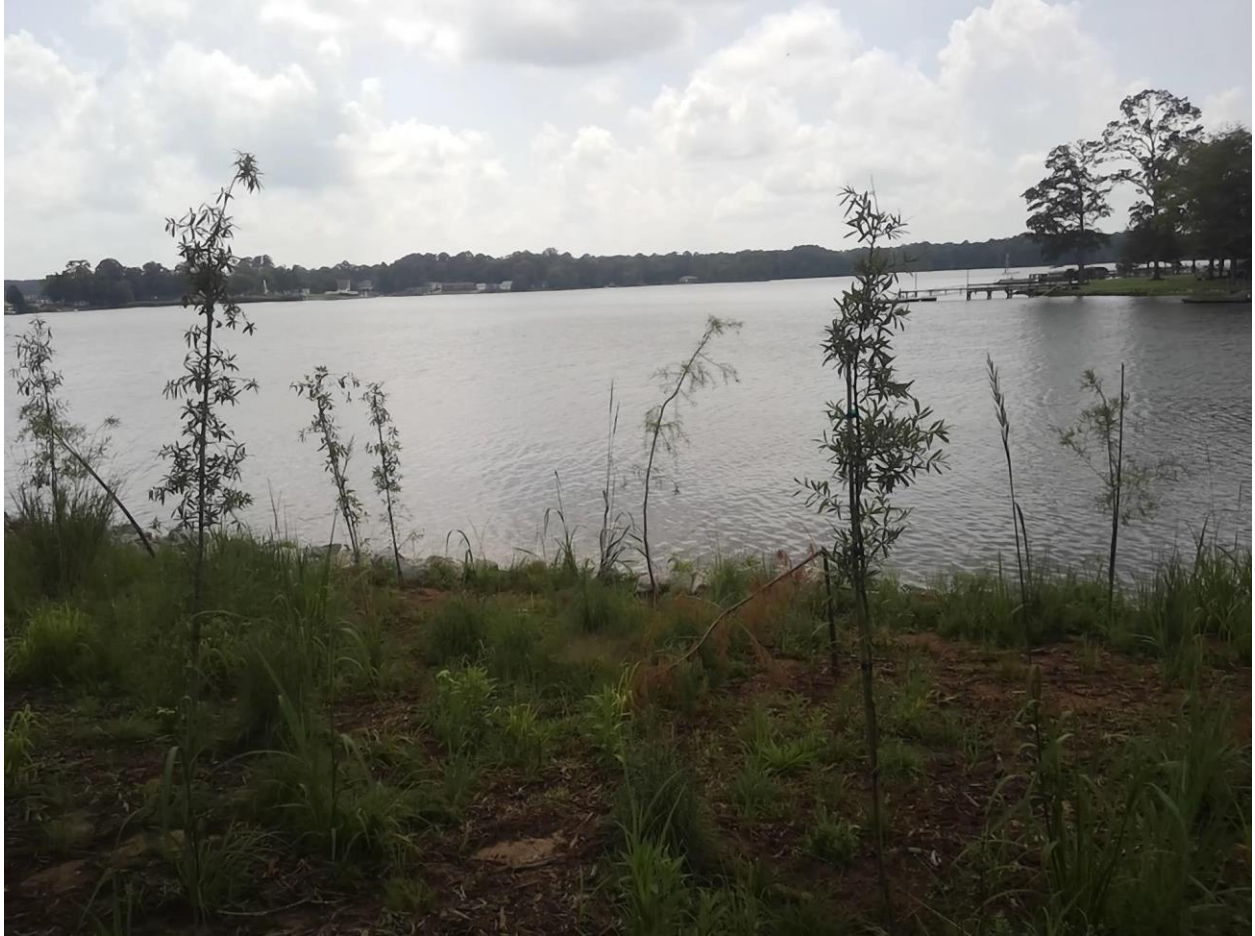
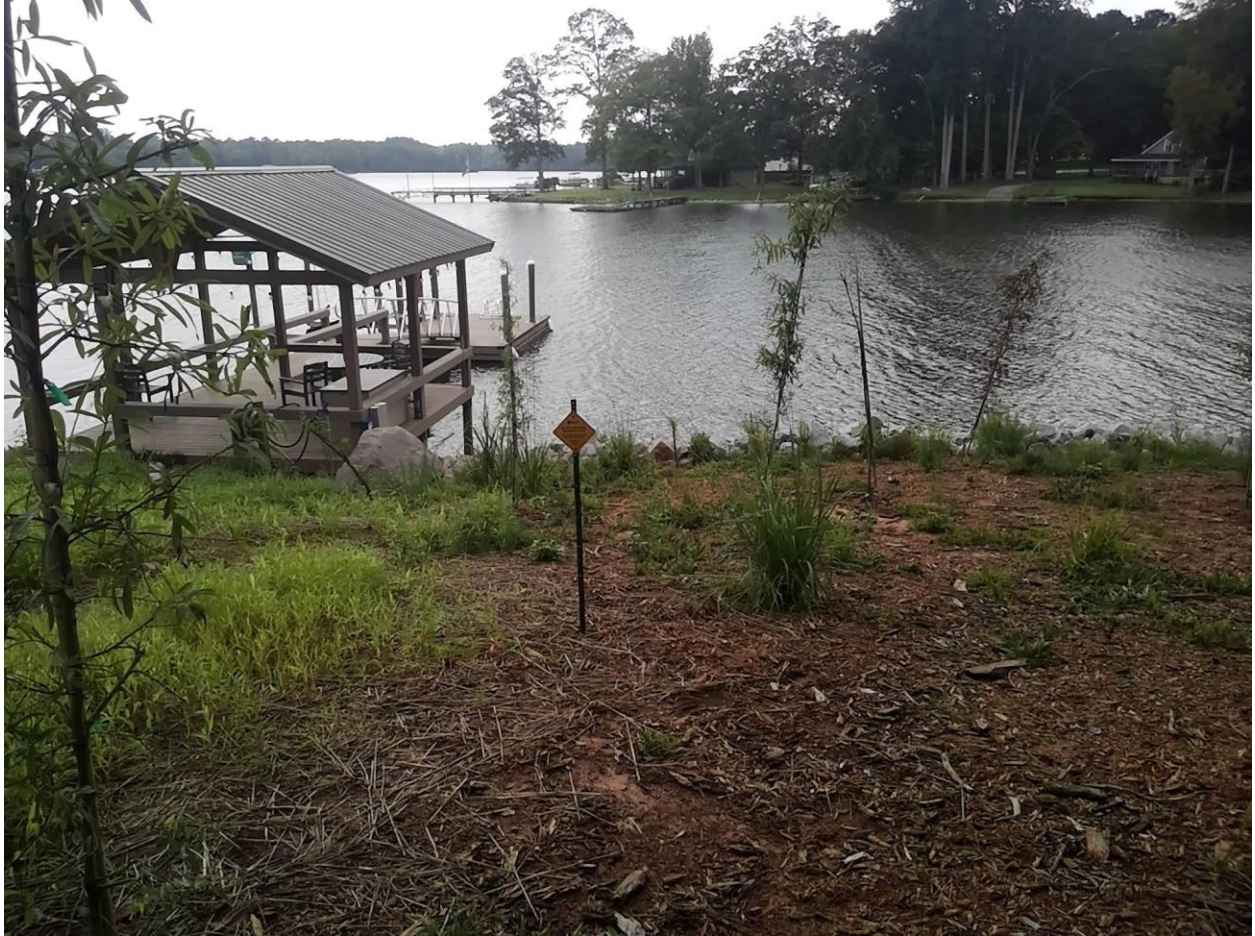
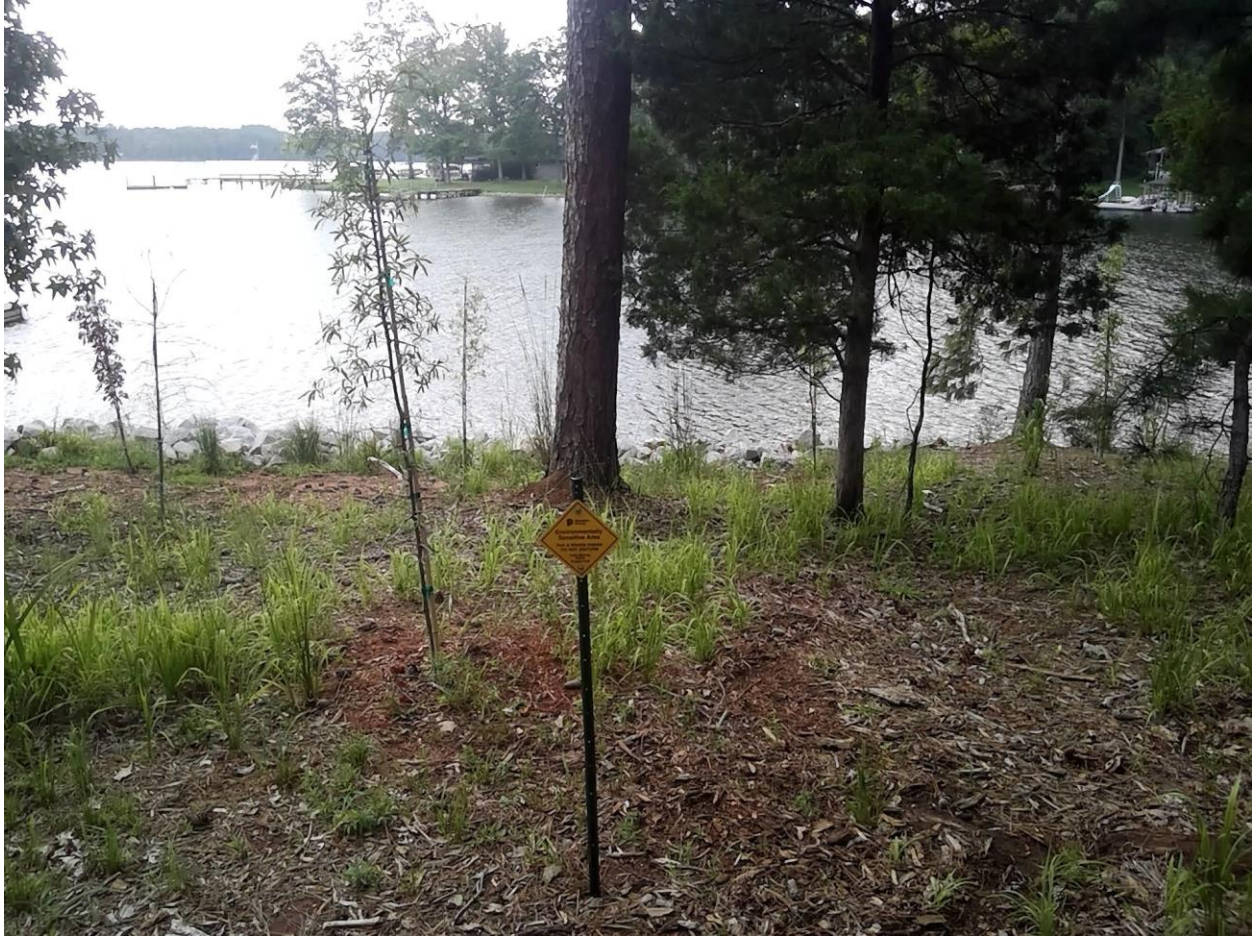
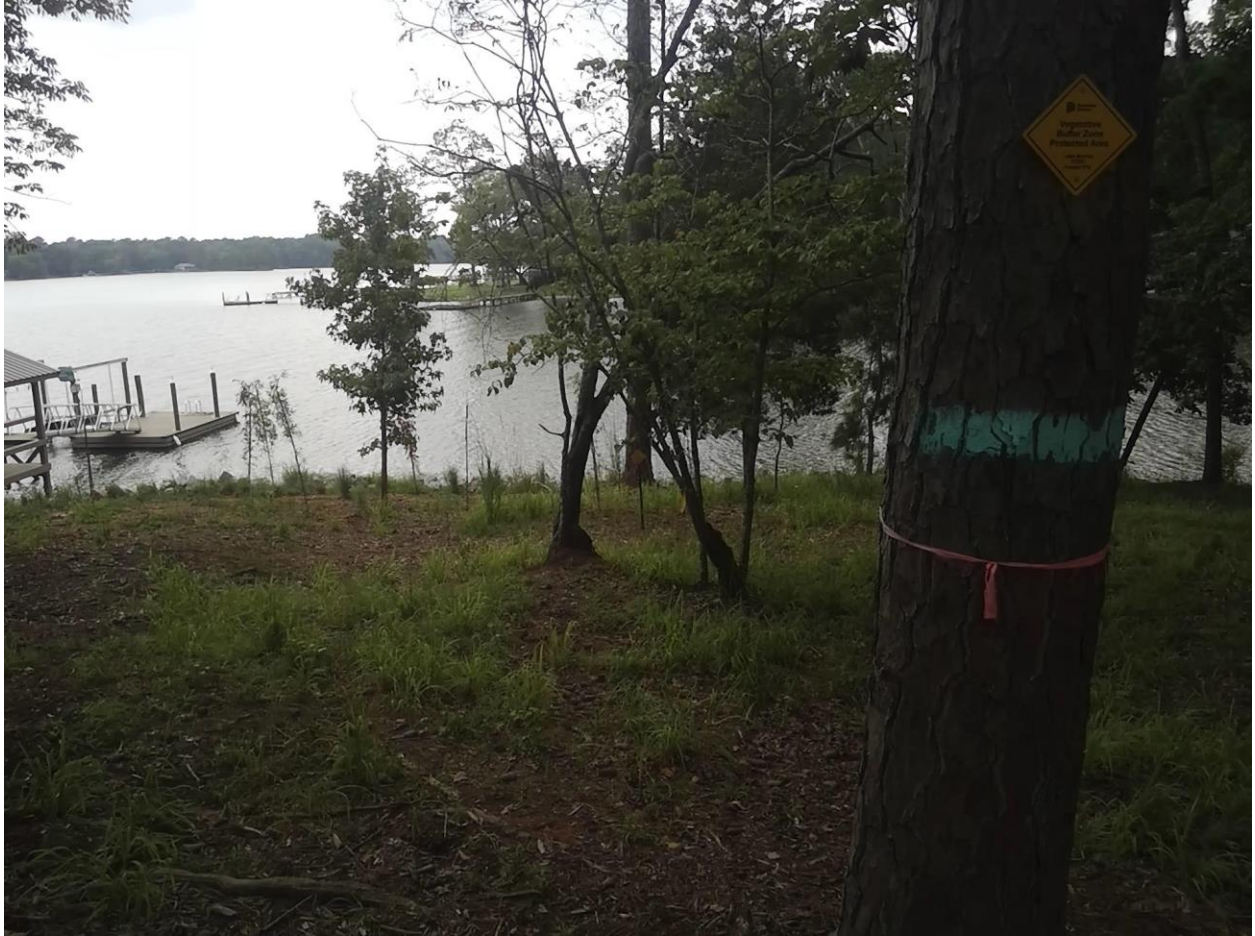
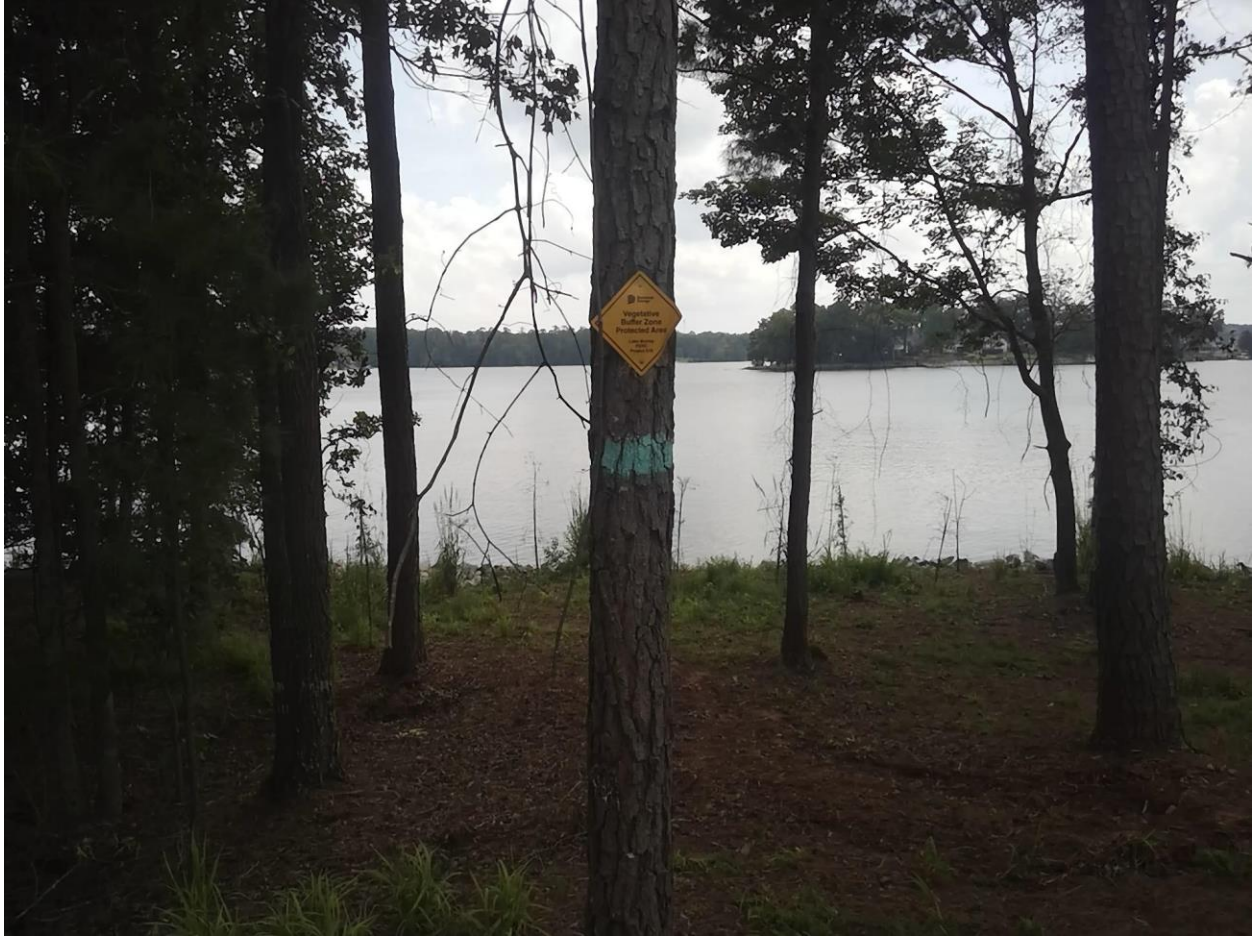
See the next 8 pictures for 288 Vinge Rd (part of Lominick tract) Signed and Painted according to 2004 order.

Response: The contractor who was hired by the property owners used a mulching head to grind the damaged and dead trees on the buffer (most of them on the shoreline were undercut from wave action thus creating a safety hazard in the event they fell). DESC was not aware machinery was being used to this extent and no authorization for its use was given. Trees have since been re-planted according to the 2004 order and it has been signed accordingly.
